Large-scale overflow failure tests on embankments using soil bags anchored with geosynthetic reinforcements

ABSTRACT: Every year, a great number of dams for agricultural irrigation are seriously damaged or totally destroyed by flood overflow exceeding the drainage capacity of a spillway. To increase the stability of the downstream slope of such small earth fill dams against overflow, it is proposed to protect the downstream slope by using inclined soil bags anchored with geosynthetic reinforcement. Two tests on hydraulic overflow-induced collapse of the downstream slope were performed on full-scale models, 3.5 m high and 2.3 m wide with a downstream slope of 1V: 1.2H. The first test was conducted on an unreinforced soil slope subjected to a fixed level of overflow and the other was on the geosynthetic soil bags with extended tails (GSET) in which soil bags were placed on the downstream slope and subjected to stepwise increased levels of overflow. Results showed that the GSET model protected by using the soil bag system was stable enough against temporary flooding at overflow levels required in the field. In particular, the rate of progressive erosion of the downstream slope when s

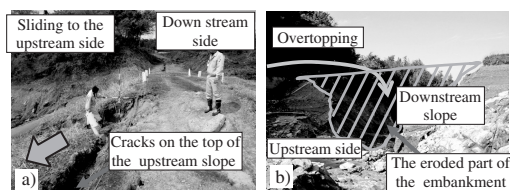
Photo 1. Failures of small earth dams: a) by the Niigata-chuetsu earthquake in 2004 in Kawaguchi town; and b) totally collapsed by heavy rainfall during Tokage typhoon No.200423 in Awaji Island.

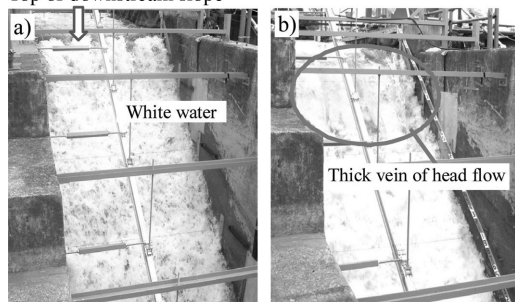
When the overflow depth, h_0 , increased to between 23.8 cm and 32.3 cm (i.e., S/d_c became 0.649–1.248), a thick vein head flow, separated from the top of the downstream slope, started forming, which gave an impact on a limited number of soil bags. As seen from Photo 2b, a heavy flow started entraining air at some distance after having leaped over several soil bag steps below the starting point (Fig. 10b). This stream regime entraining air is basically classified into skimming flow, which is consistent with the upper limit of S/d_c for the formation of skimming flow in the case of a stepped spillway, $S/d_c = 1.126$ at $\alpha = \tan^{-1}(1/1.2)$, according to Yasuda et al. (1999). Skimming

Photo 2. Stream regime on the downstream side: a) Overflow level 1 at $q = 0.087 \text{ m}^3/\text{s/m}$; and b) Overflow level 2 at $q = 0.348 \text{ m}^3/\text{s/m}$.

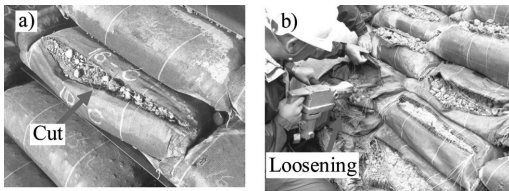
At the subsequent test stage, artificial physical damage was given to the soil bags repeatedly, four times, by cutting the surface of geotextile soil bag and loosening the infill material, as shown in Photo 4, during overflow testing for a total period of 150 min at a discharge rate of $q = 0.348 \text{ m}^3/\text{s}/\text{m}$ at respective stages between damaging operations. It was found that the

Photo 4. Artificial physical damage: a) Cut of the surface of geotextile soil bag; and b) Loosening of the infill material.

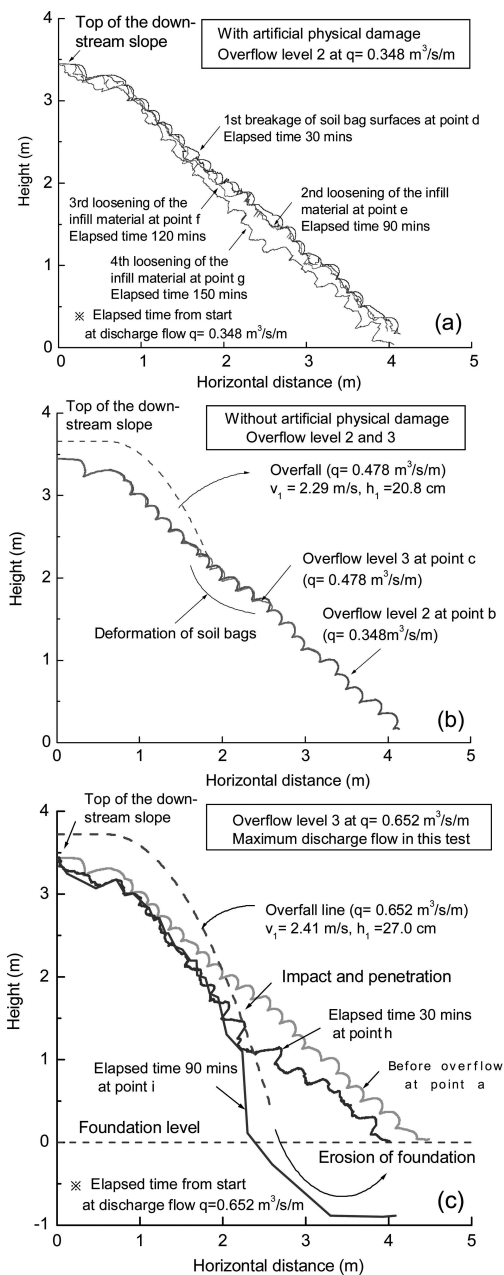
infill material (i.e., crushed concrete aggregate) had been slightly cemented by hydration of remaining cement. Figure 11a shows the profile of the deformed downstream surface at stages d, e, f and g plotted in

Fig. 9. It seemed that impact and tractive forces by water flow were strong and infill material was washed out in the vicinity of the places of artificial loosening. Subsequently, as schematically shown in Fig. 12, the torn-off edge part of a geotextile sheet of soil bags became like a flange, covering and sealing the torn-off area while preventing further erosion of infill material from the inside of soil bags. Subsequently at overflow level 2, progressive erosion did not develop. Furthermore, it is likely that the combination of dense arrangement of geotextile sheet inside the slope and slight cementation of the infill material contributed significantly to the high stability and resistance of the slope surface, preventing serious damage.

inside of the slope (Photo 5a and Fig. 10c). Fig. 11b presents the profile of the deformed downstream surface at stages b and c in Fig. 9 (before giving artificial physical damage to the soil bags). It was found that a limited number of soil bags deformed severely due to impacts by over-fall of a very thick vein.

Figure 11c shows the profile of the deformed downstream surface after periods of 30 min and 90 min since the start of flow at a rate of $q = 0.652 \text{ m}^3/\text{s}/\text{m}$, at stages h and i plotted in Fig. 9, after having given artificial physical damage to the soil bags. It was found that, after 90 minutes, the erosion had reached the foundation of the slope along the axis of waterfall formation. Differently from overflow level 2, a free fall having sufficient force to penetrate the soil bags was formed, which resulted in severer progressive erosion. Photo 5b shows a trace of deep erosion that was formed by a waterfall. This erosion, which reached the foundation,

Figure 11. Distributions of displacement on downstream slope surface at: a) points d, e, f and g; b) points b and c; c) points a, h and i.

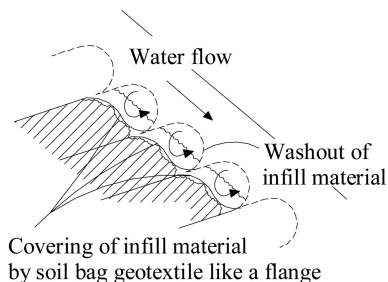
Figure 12. Schematic diagram of erosion on the downstream slope with densely arranged geotextile layers in case of the artificial physical damage at overflow level 2.

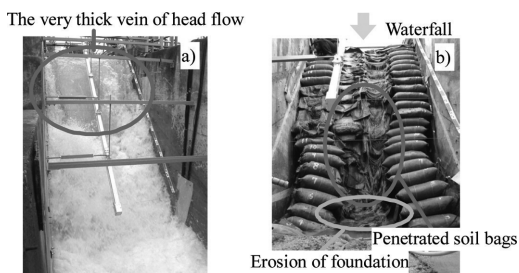
is critical damage to the slope for the stability of the embankment. However, the rate of development of erosion with the reinforced slope was substantially slower than with the unreinforced slope, which collapsed at 5 min (as shown in Photo 6) at a much lower discharge of $q = 0.050 \text{ m}^3/\text{s}/\text{m}$. It is to be noted that, even after this severer erosion in the slope, the settlement at the crest of the GSET-spillway was negligible due likely to reinforcement effects. This high performance of the GSET-spillway shows that this technology can alleviate serious damage to the downstream slope caused by overflowing of earth dams.

Photo 5. Overflow level 3 (serious damage): a) Stream regime on the downstream side at overflow level 3 at $q = 0.652 \text{ m}^3/\text{s/m}$; and b) Erosion trace like the formation of a waterfall basin after final overtopping.

The test results showed that a long free fall creates strong penetration force, which results in severe damage on the downstream slope for a small earth dam. It is therefore important both to reduce the penetration force and to increase the resistance against such force of soil bags. To this end, it is suggested: 1) to arrange a short slope with a gentle gradient from the top corner to the impact point at the upper part of the downstream slope; and 2) to reinforce the surface of soil bags at the impact point to provide sufficient resistance against the penetration force.
