PROCEEDINGS OF THE INTERNATIONAL SYMPOSIUM ON EARTH REINFORCEMENT  
FUKUOKA/KYUSHU/JAPAN/12-14 NOVEMBER 1996

# Performance of reinforced soil structures during the 1995 Hyogo-ken Nanbu Earthquake

**ABSTRACT:** The performance of a number of mechanically stabilized earth retaining walls and nailed slopes during the 1995 Hyogo-ken Nanbu earthquake is reviewed. The behaviour of the reinforced soil retaining walls is compared with that of the conventional retaining walls. Some lessons from the case histories and limitations of the current seismic design methods are discussed. Reconstruction of damaged structures by soil reinforcing techniques is also presented.

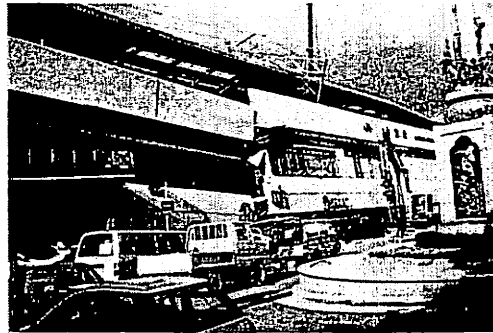
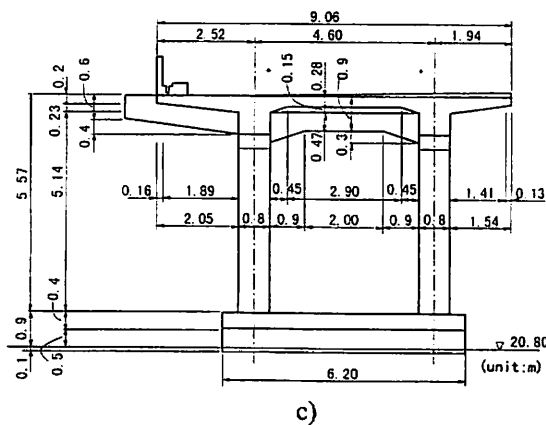
Fig. 7 a) Damaged RC frame bridge abutment and b) damaged Rokko-michi Station consisting of elevated RC frame structures, c) typical dimensions of elevated RC frame structure, and d) inverted T-shaped RC RW adjacent to Rokko-michi Station.

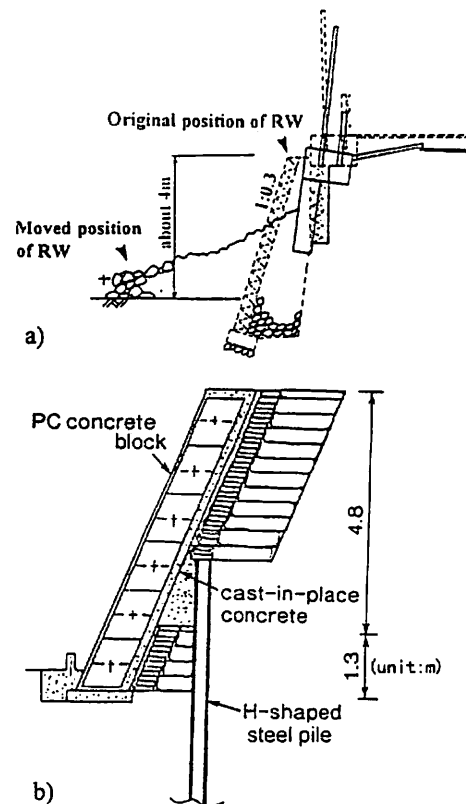
The oldest type of RW is masonry RWs. They were constructed more than 70 years ago without aseismic design. They were most seriously damaged among different types of RWs. Most of the masonry RWs located in the areas where the JMA scale was equal to seventh or higher were more-or-less damaged as typically shown in Fig. 9. Many masonry RWs supporting the backfill behind the RC bridge abutments moved outward, resulting in large settlement of the backfill relative to the pile-supported RC bridge abutments.

Fig. 9 Cross-sections of a) a typical damaged masonry RW constructed in around 1925 (MS1 in Fig. 4) and b) a GRS-RW by reconstruction (the facing consists of PC concrete blocks, which were fixed afterwards to each other and to the backfill), between Setsu-motoyama and Sumiyoshi Stations, JR Kobe Line.

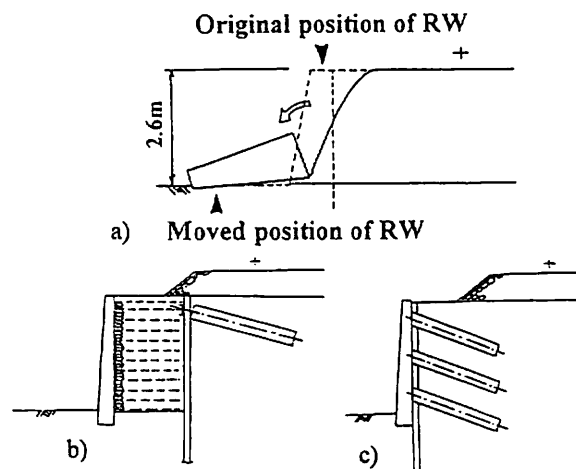
Fig. 10 Cross-sections of a) a typical damaged leaning-type RW constructed in 1937 (LT1 in Fig. 4), and b) a GRS-RW and c) a nailed RW by reconstruction, the north side slope of the embankment between Setsu-motoyama and Sumiyoshi Stations, JR Kobe Line.

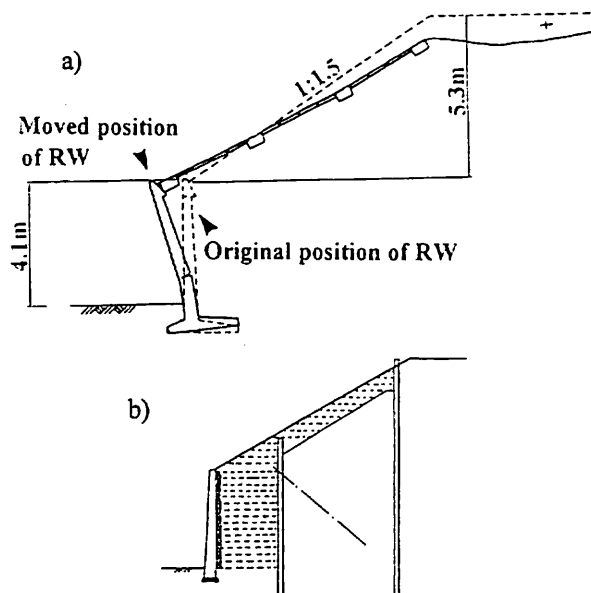
Shin-Nagata Station of the JR Sanyo Line was constructed around 1965 on the crest of a sloped embankment. Both sides was supported by cantilever-type (or inverted T-shaped type) RC RWs for a total length of about 800 m (Fig. 11a). The walls were aseismic-designed using  $k_h = 0.2$ , but it is

very likely that they were not supported by piles despite a weak subsoil. Most of these RWs considerably tilted and slid outward at the bottom inducing large settlement at the top of the railway embankment. It seems that the damage was due to insufficient values of both the bearing capacity in the subsoil beneath the wall and the sliding resistance at the wall base. The most serious damage was cracking in the facing, probably due to extra-ordinary large seismic earth pressure from the sloped backfill (Fig. 11a).

Fig. 11 Cross-sections of a) a typical damaged cantilever-type RC RW without a pile foundation (CL2 in Fig. 4) and b) a GRS-RW by reconstruction, at Shin-nagata Station, JR Sanyo Line.

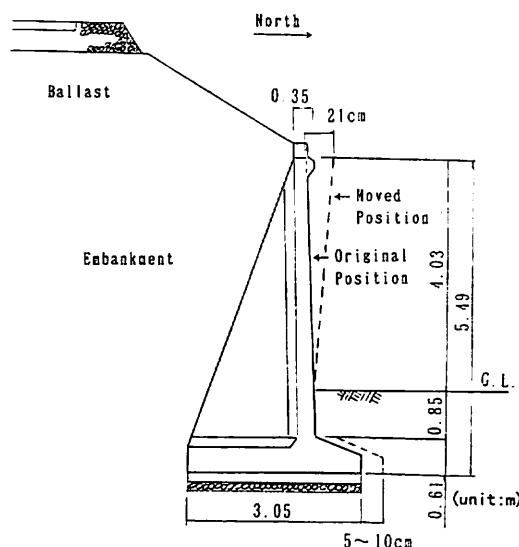
Inverted T-shaped and buttressed RC RWs which was constructed around 1938 at Shioya Station of the Sanyo Dentetsu Line, running in parallel to the JR Sanyo Line (see Fig. 4), were also seriously damaged (Fig. 12, CL11 in Fig. 3). There were no piles. Although the wall did not totally collapse, most part tilted largely for a length of about 360 m, and some part of the wall structure ruptured. Similar to the RWs at Shin-nagata, the strength of the wall structure itself and the bearing capacity of the supporting subsoil below the wall were seemingly not sufficient to prevent, respectively, the failure of the wall structure and the large tilting of the wall. The walls were removed after the earthquake.

Fig. 12 Typical cross-section of damaged buttressed RC RW without a pile foundation (CL11 in Fig. 4), Shioya Station, Sanyo Dentetsu Line.

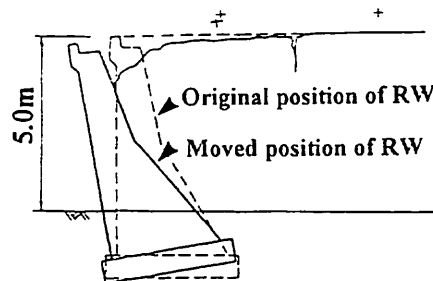
Gravity-type unreinforced concrete RWs is another old type. They were constructed more than 60 years ago. The walls at the Ishiyagawa Station of the Hanshin Line (Fig. 13, GT1 in Fig. 4) were most seriously damaged, although these walls were aseismic-designed by using  $k_h=0.2$ .

Fig. 13 Cross-section of the seriously damaged gravity type unreinforced concrete RW at Ishiyagawa Station (GT1 in Fig. 4), Hanshin Railway Main Line.

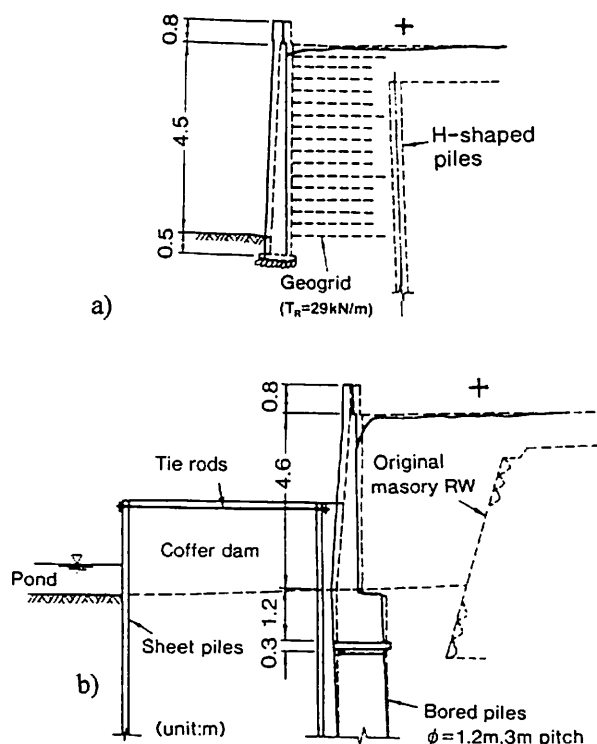
The bottom of the wall moved outward on average about 5 cm relative to the supporting foundation subsoil, pushing the subsoil in front of the wall laterally. At the highest part of the wall, which was in contact with a RC box culvert structure crossing the railway embankment, the largest outward displacement occurred, which was 26 cm at the top of the wall and 10 cm at the ground surface level (Fig. 24a).

Fig. 24 Deformation due to the earthquake of a) GRS-RW and b) RC RW with piles at Tanata.

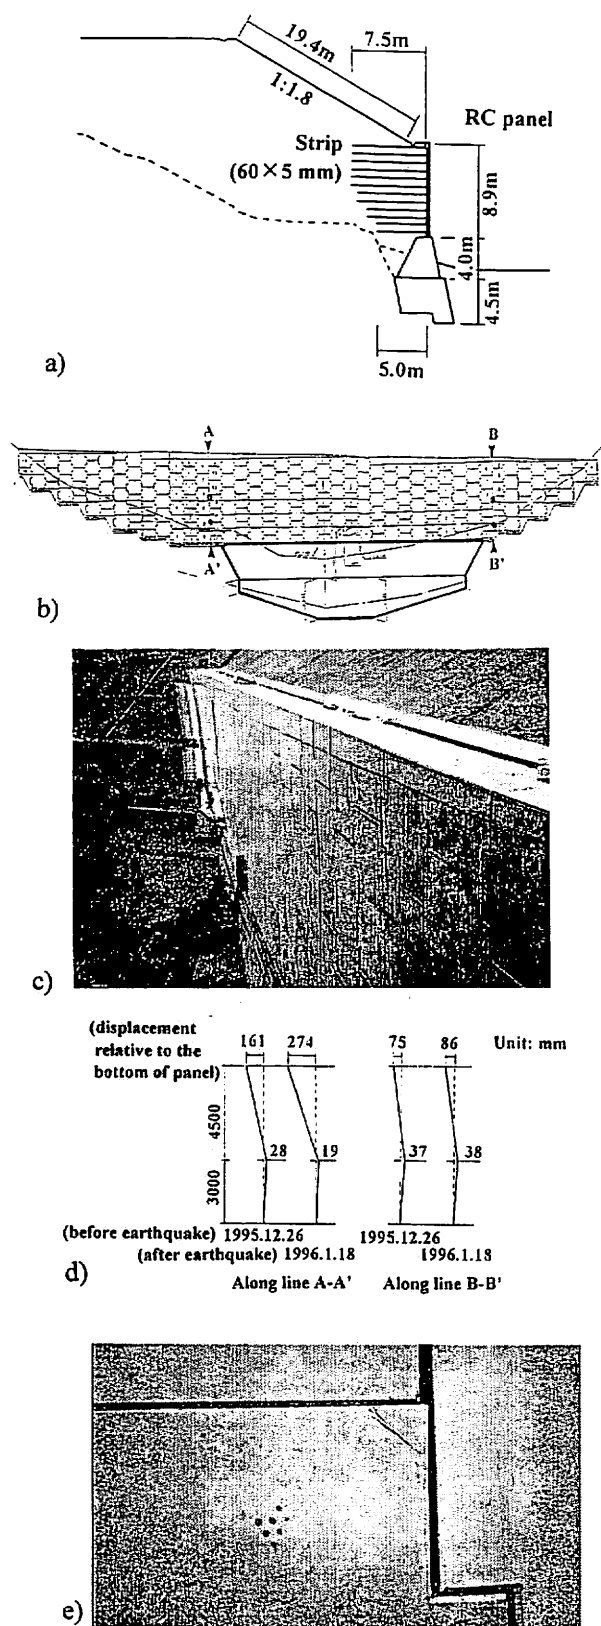
Fig. 27 shows a relatively large scale *Terre Armee* RW that was completed in January 1994 in Awaji Island (TA1 in Fig. 3) as a part of the approach road

Fig. 27 a) Cross-section, b) front view, c) general view, d) wall deformation and e) cracking at the corners of RC panel, Terre Armee wall in Awaji Island (TA1 in Fig. 3) (JTAA, 1995).

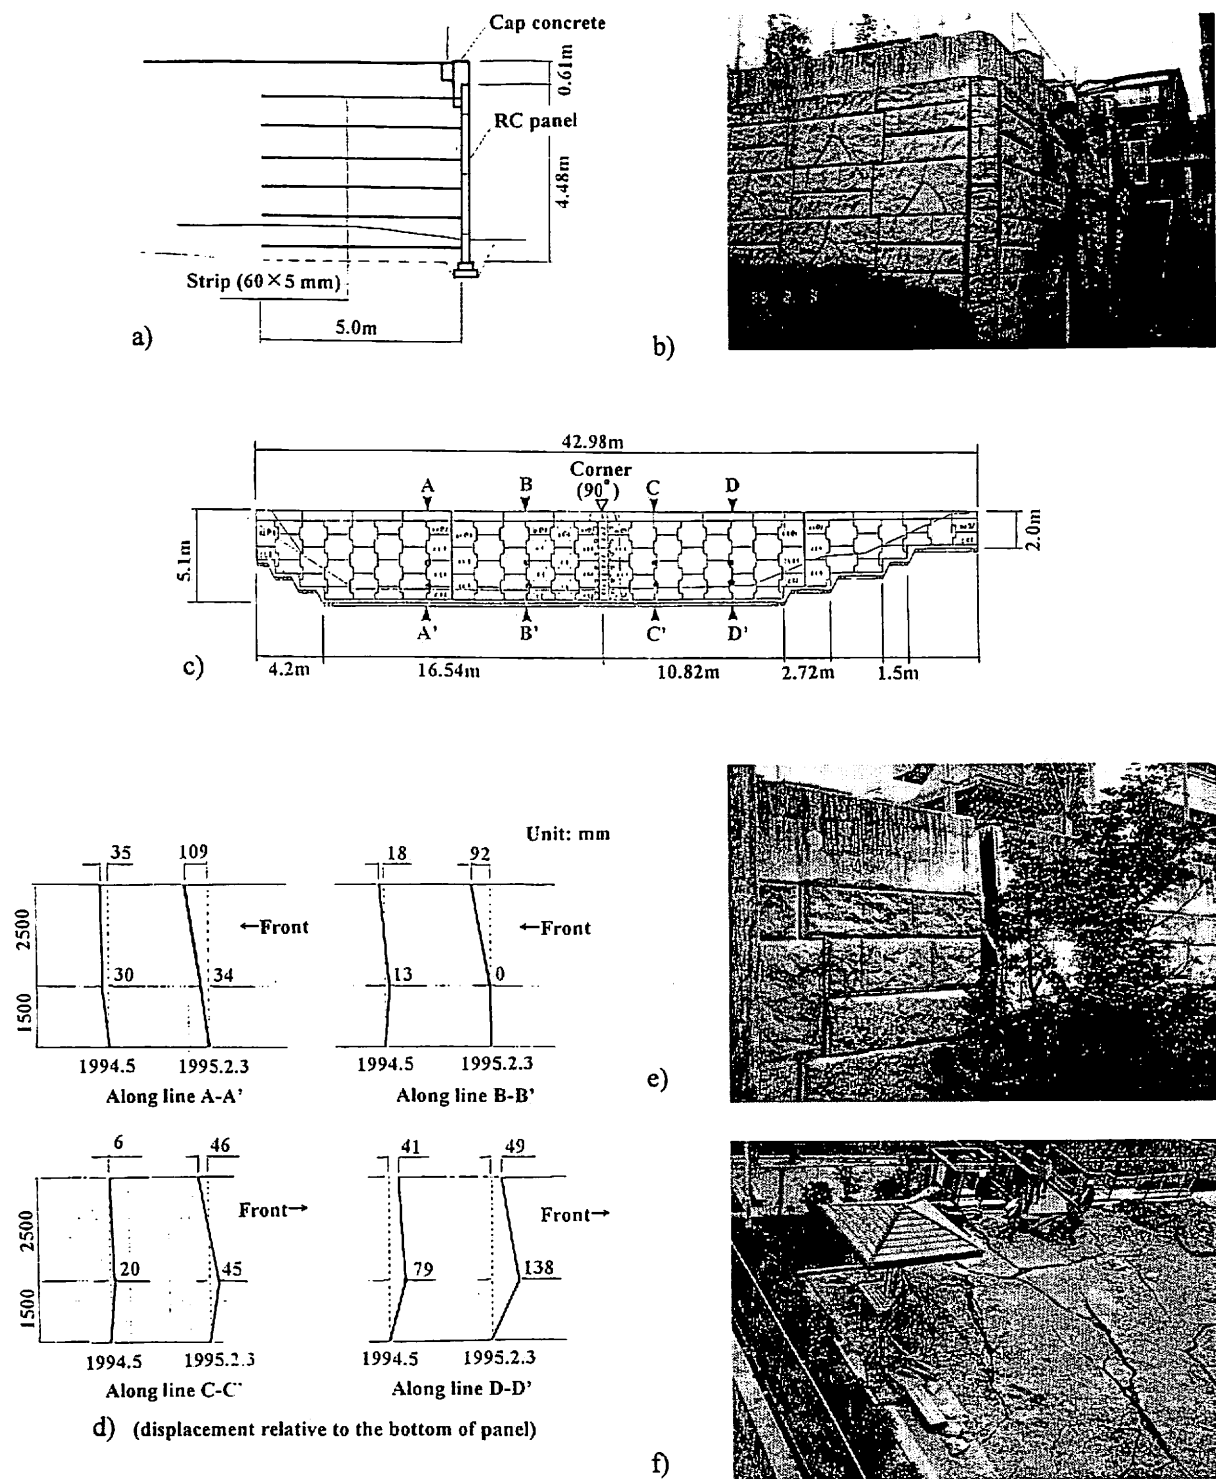
Fig. 28 a) Cross-section, b) general view, c) expanded front view, d) wall deformation, e) opening at a vertical construction joint and f) cracking on the embankment surface, Terre Armee wall for Hosiga-oka Park, Kobe City (TA2 in Fig. 3) (JTAA, 1995).

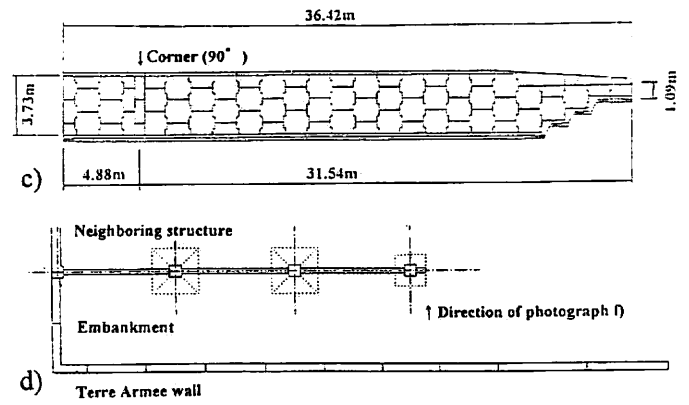
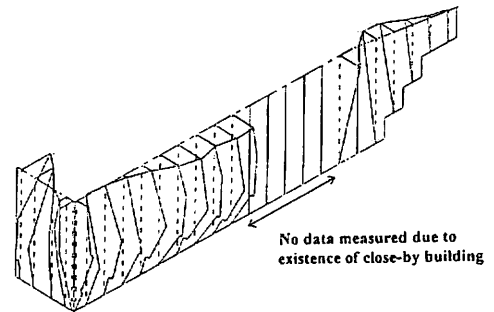
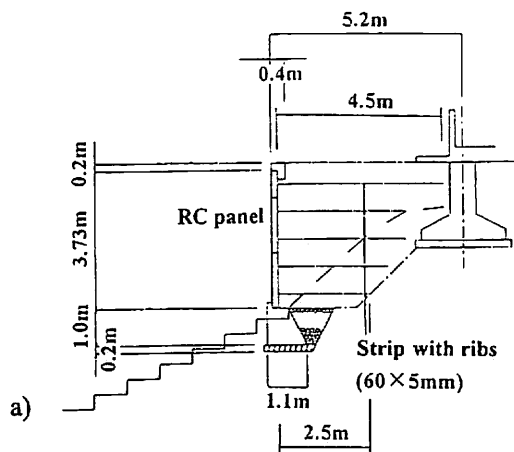
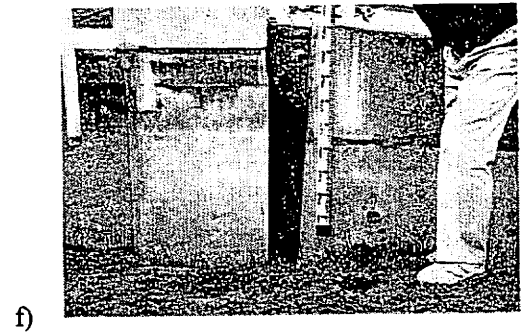
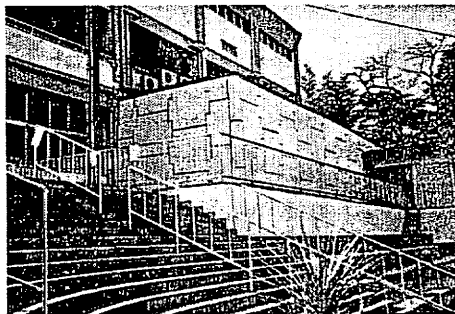
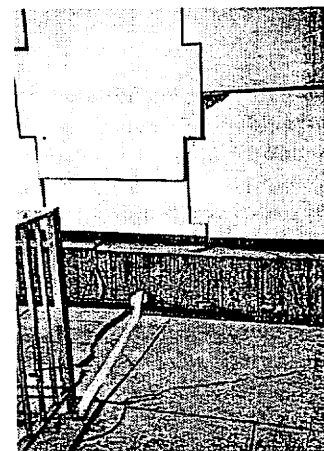
Fig. 30 (TA3 in Fig. 3) shows another permanent Terre Armee RW which exhibited relatively large deformation (JTAA, 1995, Matsui et al., 1996). This wall was completed in June 1980, having a largest wall height of 3.27 m and a total wall area of 120 m<sup>2</sup>. The top of the wall moved outward 94 mm at the largest. However, considering the fact that the top surface of the backfill settled 20 cm to 100 cm, it is very likely that the base of the facing also moved outward to some extent. Also for this wall, corner portions of some RC panels cracked (Fig. 30g).

Fig. 30 a) Cross-section, b) general view, c) expanded front view, d) plan, e) wall deformation, f) settlement of embankment relative to the neighboring structure, and g) cracking of the corner of RC panel, Terre Armee wall at Itami City (TA3 in Fig. 3) (JTAA, 1995, Matsui et al., 1996).

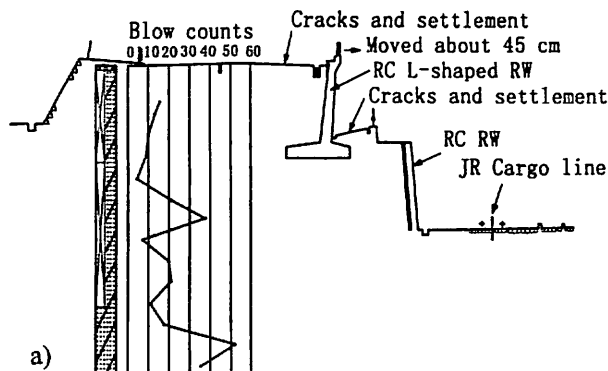
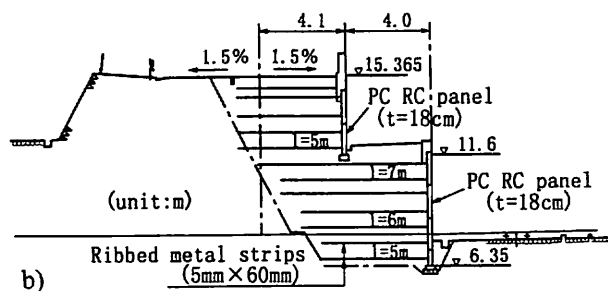
Fig. 56 a) Damaged RC cantilever RW for road embankment and b) Terre Armee wall by reconstruction, south of Nada Station, JR Kobe Line (Kobayashi and Ohtani, 1996).
