New direction for earth reinforcement: disaster prevention for earthfill dams

ABSTRACT: A large number of geosynthetic-reinforcing technologies for embankments and retaining walls have been proposed and developed, and the behaviour of these structures has been evaluated using laboratory tests and field tests, as well as full-scale case histories. Yet a great number of embankments have failed in Japan owing to strong seismic loads and heavy rainfall. Significant improvements are required in the construction of earthfill dams to prevent these failures. This paper reviews the characteristic features of the damage to small earthfill dams that has taken place during earthquakes as well as heavy rainfall. The paper then describes a new technology using geosynthetic soil bags with extended tails stacked on the downstream slope to construct earthfill dams that are highly stable against earthquakes as well as heavy rainfall leading to overtopping by flood water. Some fundamental aspects of the stability of embankments reinforced by soil bags and seismic behaviour are examined using static loading, hydraulic breach tests and shaking-table tests.

KEYWORDS: Geosynthetics, Disaster prevention

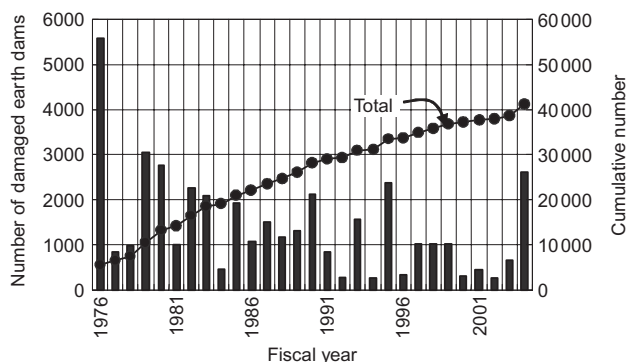
Figure 1. Annual and cumulative numbers of damaged small earthfill dams in Japan. 1995 data include 1200 sites damaged by the Hyogoken-Nanbu earthquake; 2004 data include 561 sites damaged by the Niigataken-Chuetsu earthquake.

Figure 1 shows the cumulative and annual numbers of damaged small earthfill dams in Japan, from 1976 to 2004. The figure shows that complete dam failure occurs

several times a year, but most small earthfill dams have been damaged by sliding and leakage. It is obvious that many dams were damaged by severe seismic loading during the 1995 Hyogoken-Nanbu earthquake and the 2004 Niigataken-Chuetsu earthquake, but over 300 dams were adversely affected by slip failure of embankment and overflow caused by rainfall every year.

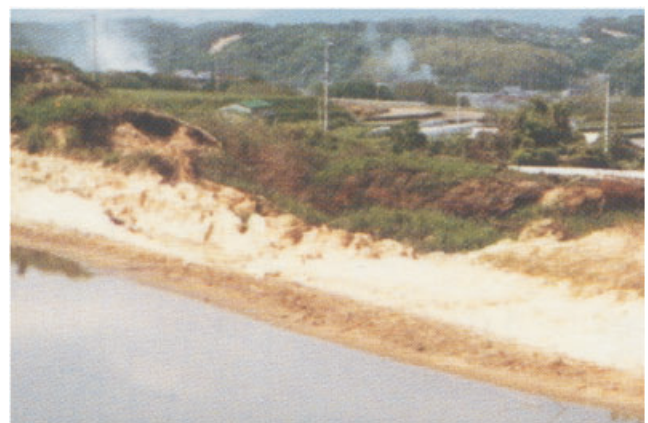
Figure 4. Total failure and large settlement caused by Kobe earthquake, due to liquefaction (Hyogo Pref. 1996)

Figure 4 shows a damaged small earthfill dam, in which the whole dam dyke underwent large settlement, owing to widespread liquefaction of the foundation below the dyke.

The crest of the dam settled about 5 m during the earthquake, and many soil boils were found around the dyke. Figure 5 shows slip failure on the upstream slope of a small earthfill dam that consisted of clay materials.

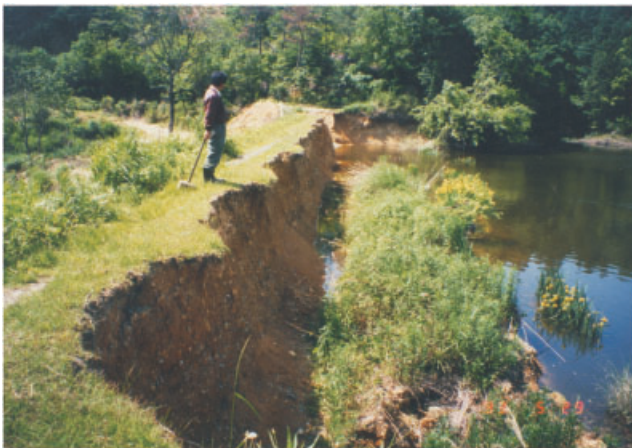
Figure 5. Upstream slope sliding by seismic loading (Hyogo Pref. 1996)

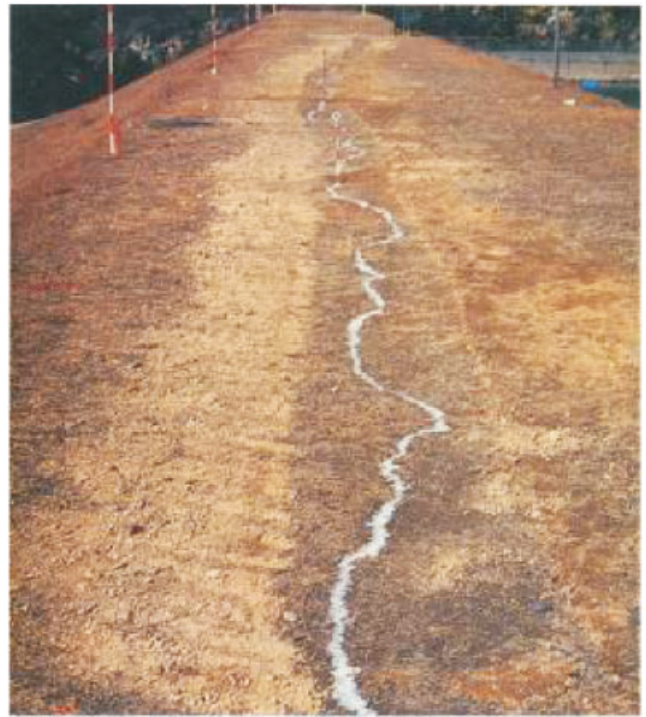
Figure 6. Open crack in direction parallel to dam axis (Hyogo Pref. 1996).

Because of the motion of the embankment during an earthquake, its crest surface is often cracked. As shown in Figure 6, several continuous cracking events parallel to the embankment axis can occur. These surface cracks may extend to the depth of the embankment, even if the opening width of the surface is only approximately 0.05 m. In one small earthfill dam hit by the 1995 Hyogoken-Nanbu earthquake, cracks reached the bottom of the impermeable core layer, as shown in Figure 7, so the entire dam had to be excavated to reconstruct a new embankment. In cases where slope sliding as well as cracking is caused by an earthquake, larger cracking occurs on the crest surface, and such a damaged dam will require large-scale rehabilitation, including the slope.

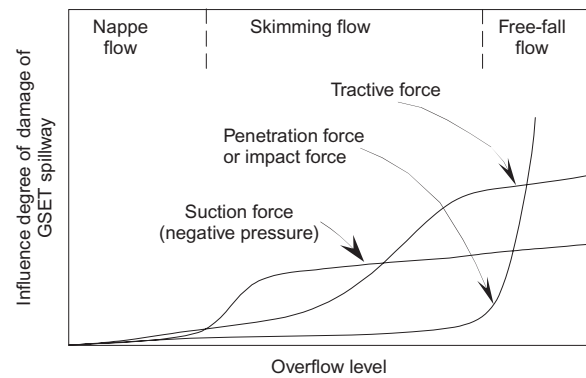
Figure 13. Damage mechanism of GSET spillway as a function of overflow level

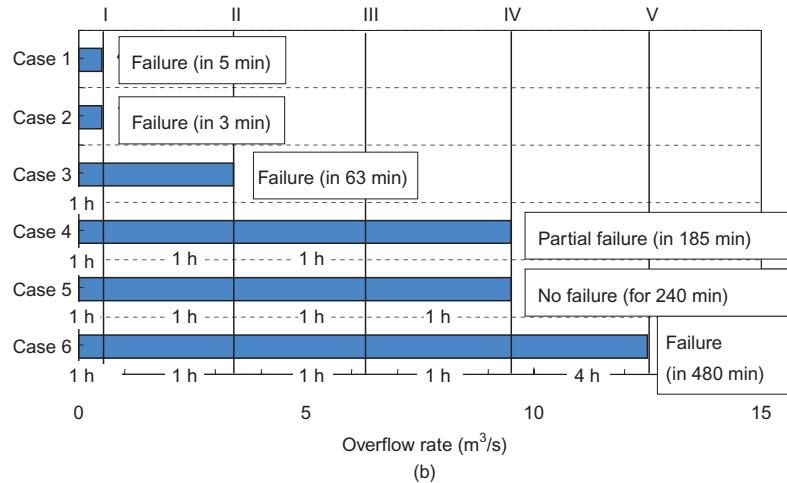
Figure 14. Overflow line and results for small-scale breaching tests (after Yamazaki *et al.* 2006): (a) depth level of flowing water; (b) flow level

Figure 14a also illustrates the stream line on the slope at the constant flow rate in the cases where the slope may suffer failure by washing out of the slope surface, and the depth of overflowing water at the crest. Figure 14b shows that protecting the slope surface by using GSET with sufficient overlap between vertically adjacent soil bags (cases 3 to 6) increases the stability against overflow in comparison with cases 1 and 2. The first phase of failure of a slope embankment by overflow is initial failure of the protective cover on the downstream face of the fill. Of

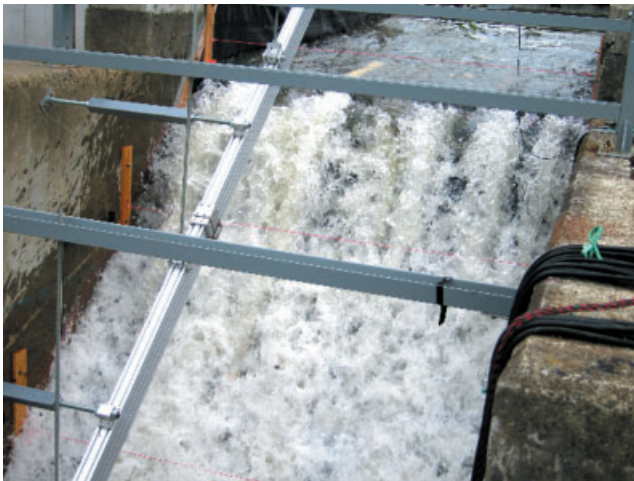
Figure 18. Stream regime on downstream side at overflow level 1 at $q = 0.087 \text{ m}^3/\text{s/m}$, $h_0 = 0.190 \text{ m}$

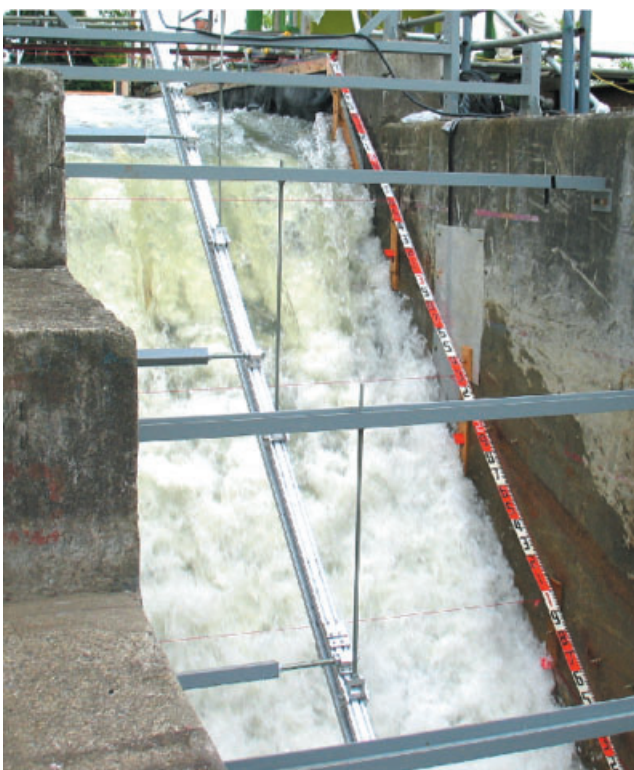
Figure 19. Stream regime on downstream side at overflow level 2 at $q = 0.348 \text{ m}^3/\text{s/m}$, $h_0 = 0.323 \text{ m}$

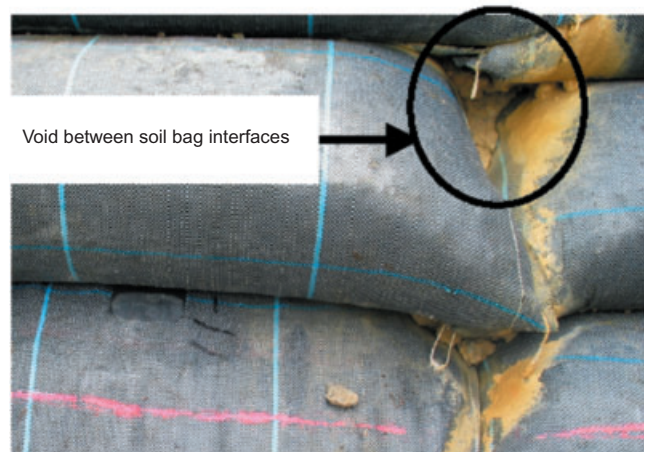
Figure 20. Evidence of sucked backfill material in cell zone behind stacked soil bags

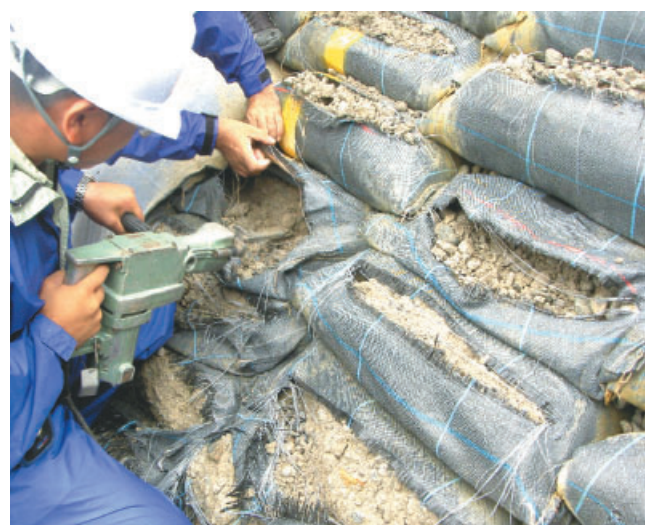
Figure 21. Artificial physical damage: cutting surface of geotextile soil bag, and loosening backfill material

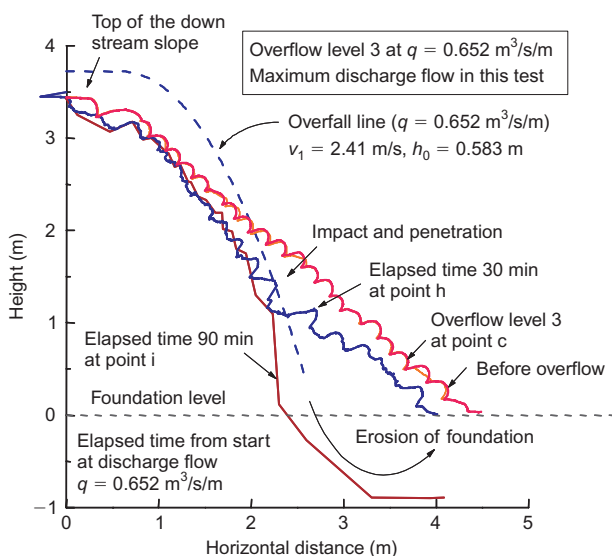
Figure 22. Distributions of horizontal displacement on downstream slope surface (after Mohri *et al.* 2007)

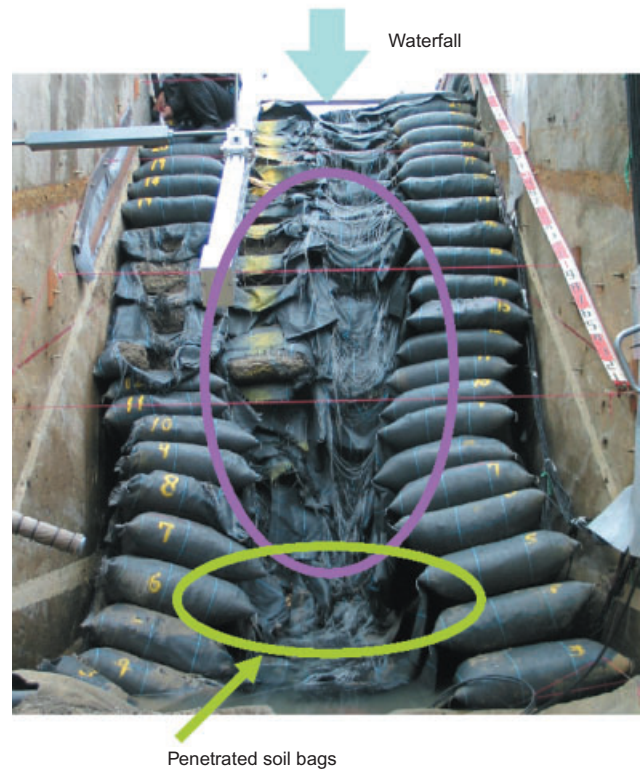
Figure 23. Erosion trace like the formation of a waterfall basin after final overtopping

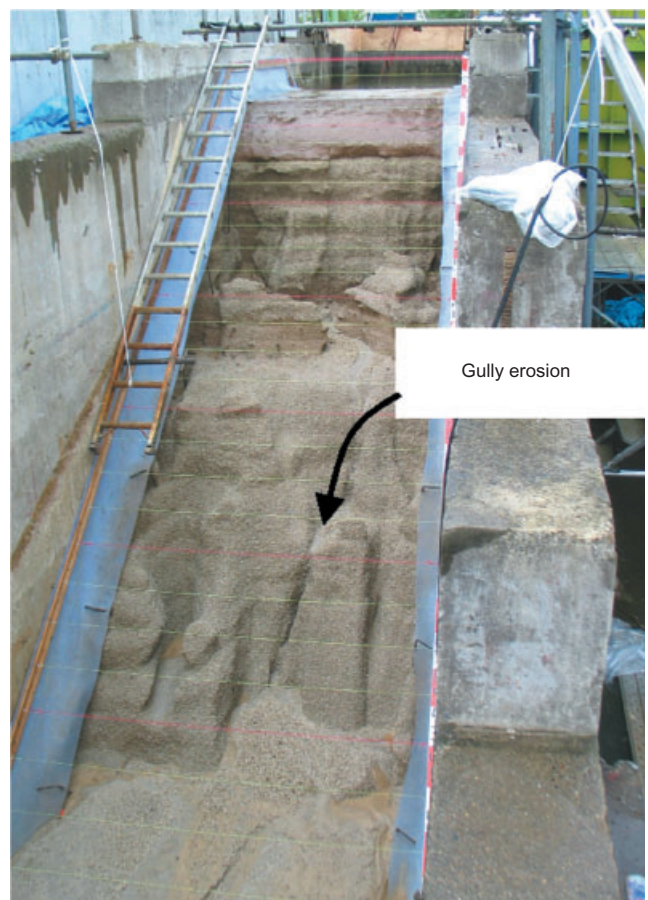
Figure 24. Erosion trace on unreinforced soil slope after 5 min at $q = 0.050 \text{ m}^3/\text{s}/\text{m}$

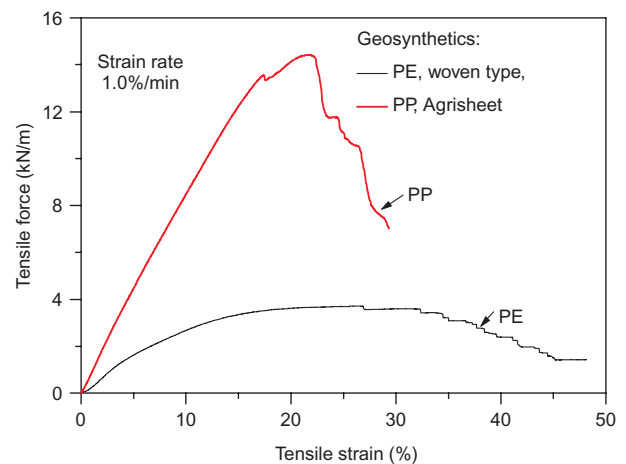
Figure 25. Tensile force–strain relation for tensile test on PE and PP woven geosynthetic used as soil bag material (after Lohani *et al.* 2006)

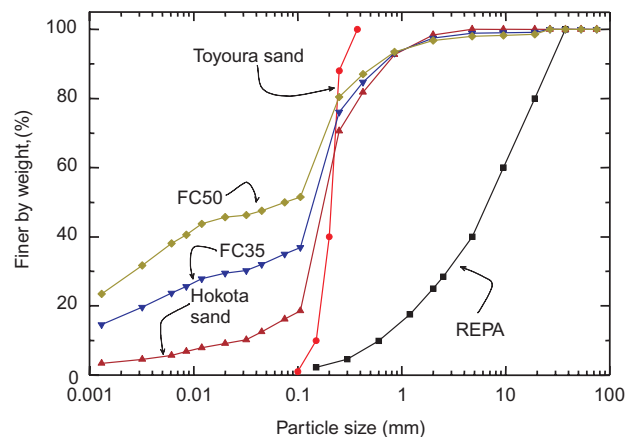
Figure 26. Particle size distribution curves of backfill materials (after Lohani *et al.* 2006)

Figure 26 shows the grain size distribution curves of the backfill materials. Only REPA was used as backfill of the

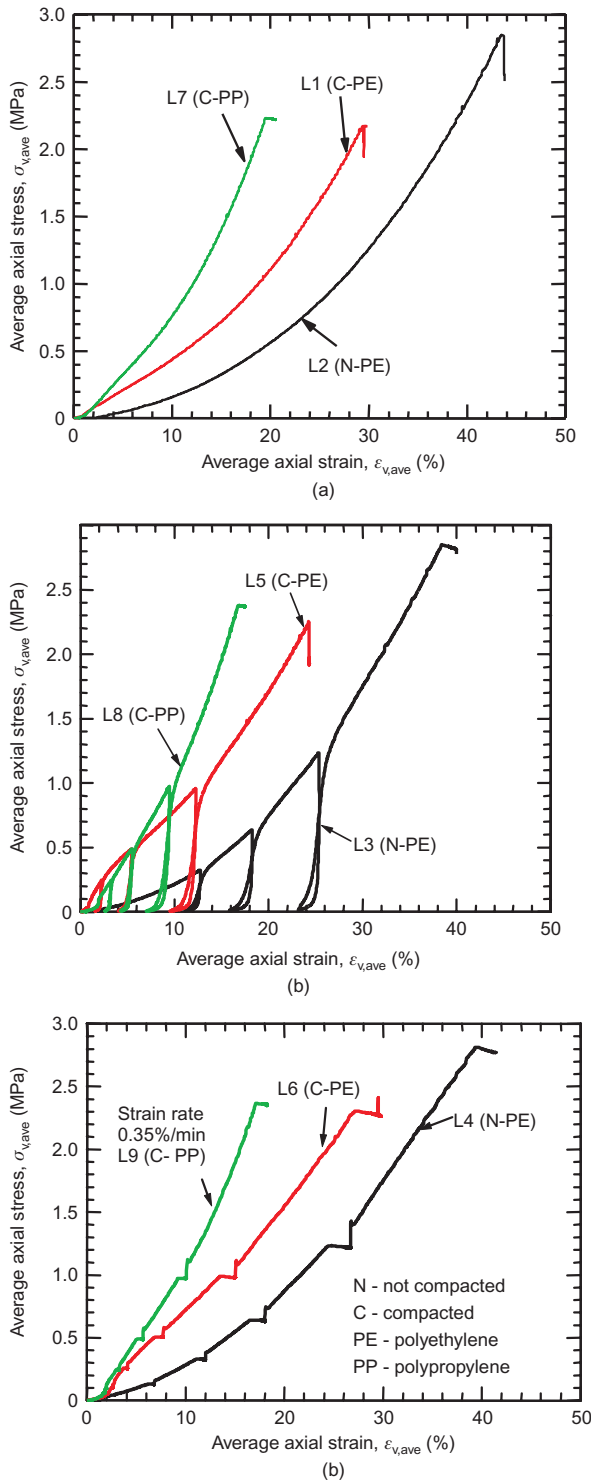
Figure 28. Average stress–strain relations from vertical compression tests on stacked soil bags, showing effect of initial compaction, and material used for bags (after Lohani et al. 2006): (a) compaction effect; (b) preloading effect; (c) creep effect

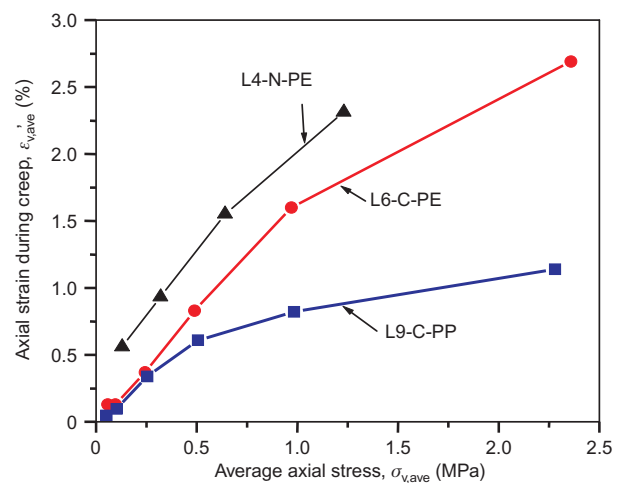
Figure 29. Effect of compaction and material used for soil bag preparation in series L tests (after Lohani et al. 2006)

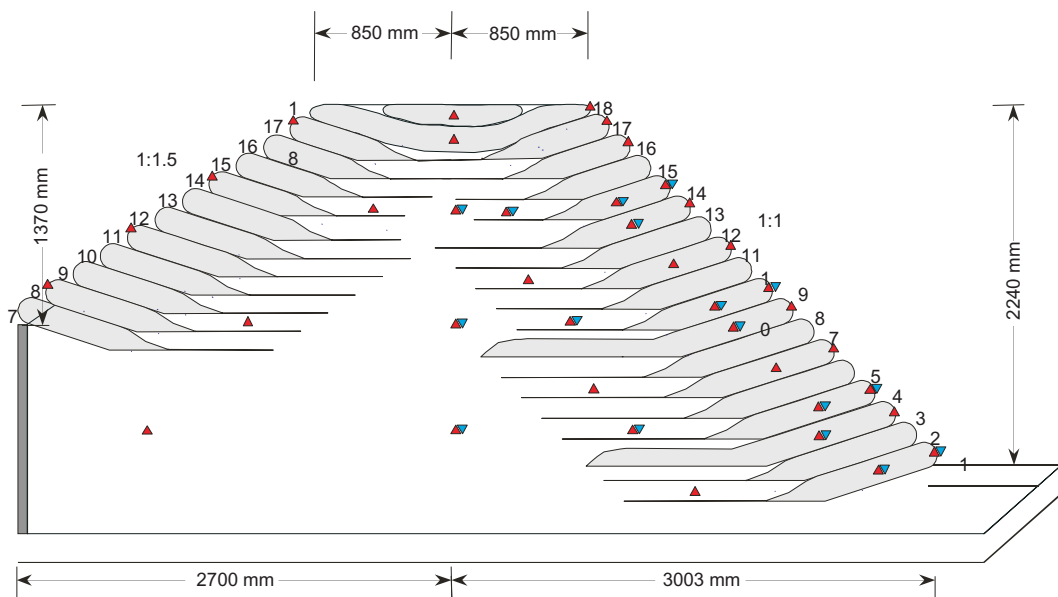
Figure 35. Cross-section of GSET reinforced earth dam (inclined model)

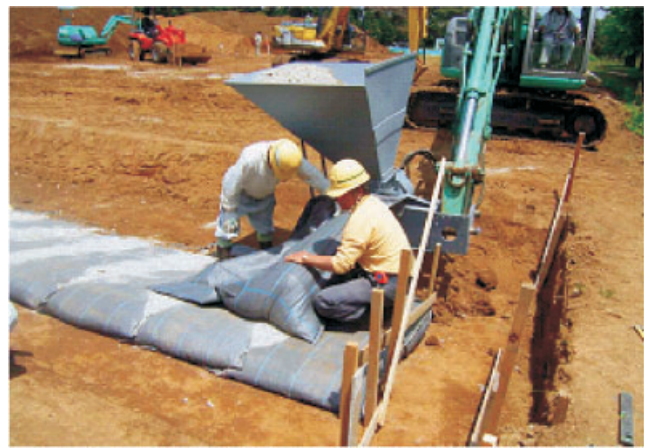
Figure 45. Typical screw extruder for filling soil bags (after Mohri et al. 2007)
