# Remedial treatment of soil structures using geosynthetic-reinforcing technology

## Abstract

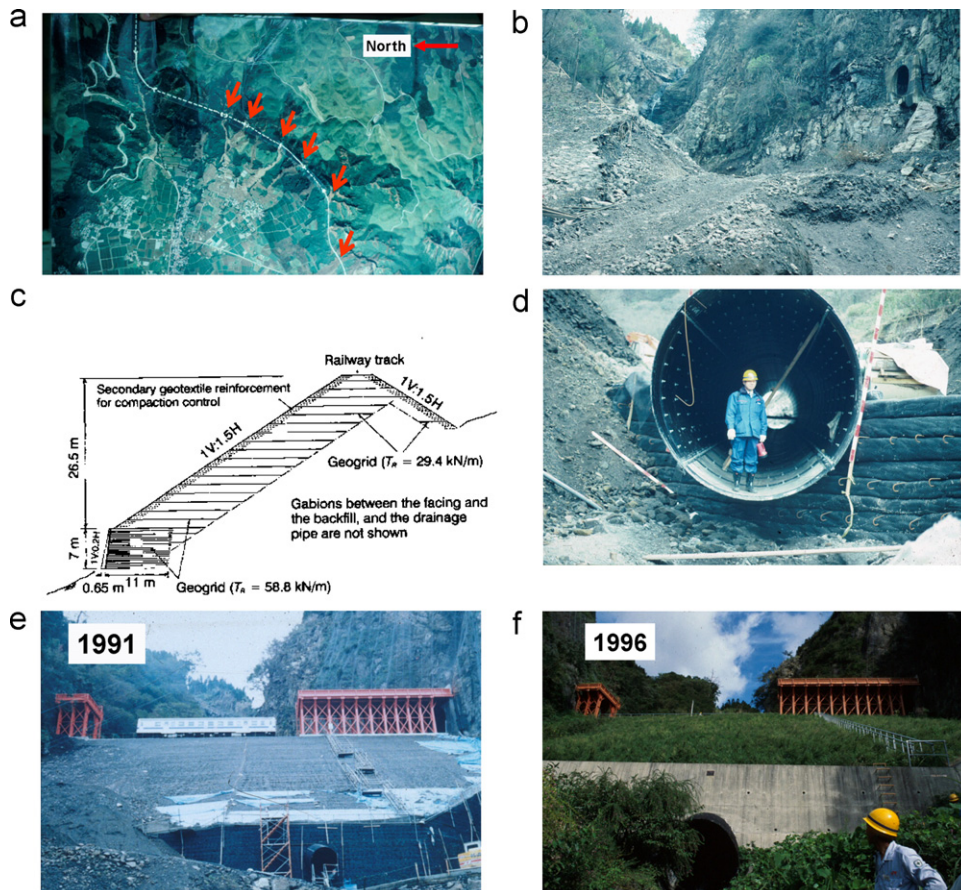
Fig. 11. Mount Aso site of Ho-hi Line: (a) air view of the site; (b) typical failed embankment; (c) typical cross section of reconstructed embankment; (d) a large-diameter corrugated steel drainage pipe installed in the reconstructed embankment; and (e) and (f) views during and after reconstruction.

the respective embankments. The entire sections of six embankments were reconstructed (Fig. 11). To reduce the amount of earthwork, a nearly vertical GRS-RW with a

FHR facing was constructed at the downstream toe of the respective embankments, and the slope was steepened by being reinforced with geogrid layers. This remedial work is characterized by large embankment heights and a large diameter corrugated steel drain pipe installed in the respective embankments.

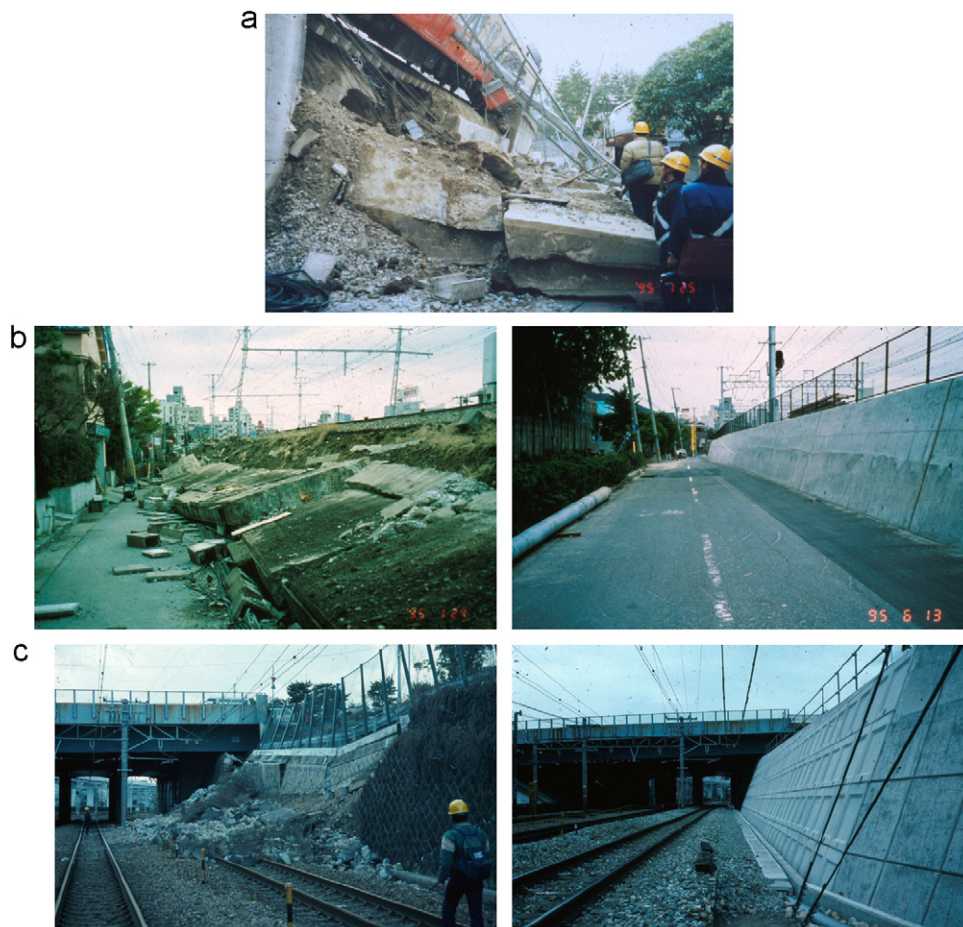
Fig. 14. Typical damage to conventional type RWs; (a) gravity-type wall at Ishiyagawa Station, Hanshin Line (site G1 in Fig. 13); and (b) and (c) gravity (leaning type) and masonry walls (sites L1 and MS1 in Fig. 13) and reconstruction to GRS-RWs with a full-height rigid facing at Sumiyoshi, JR Kobe Line.

before the earthquake. Most of the many old and new retaining walls for these embankments were seriously damaged (Fig. 14; Tatsuoka et al., 1996, 1997a, b, 1998). The conventional soil retaining walls can be categorized into four groups: (1) masonry soil walls (denoted by MS in Fig. 13); (2) leaning (supported), unreinforced concrete walls (L); (3) gravity, unreinforced concrete walls (G); and (4) cantilever or inverted T-shaped steel-reinforced concrete (RC) walls (C). The first three types of soil retaining walls were the most seriously damaged. The damage to cantilever walls was also very serious although it was generally less serious than the two conventional types of RWs described above. Many of the damaged conventional type RWs were reconstructed to GRS-RWs with a FHR facing.

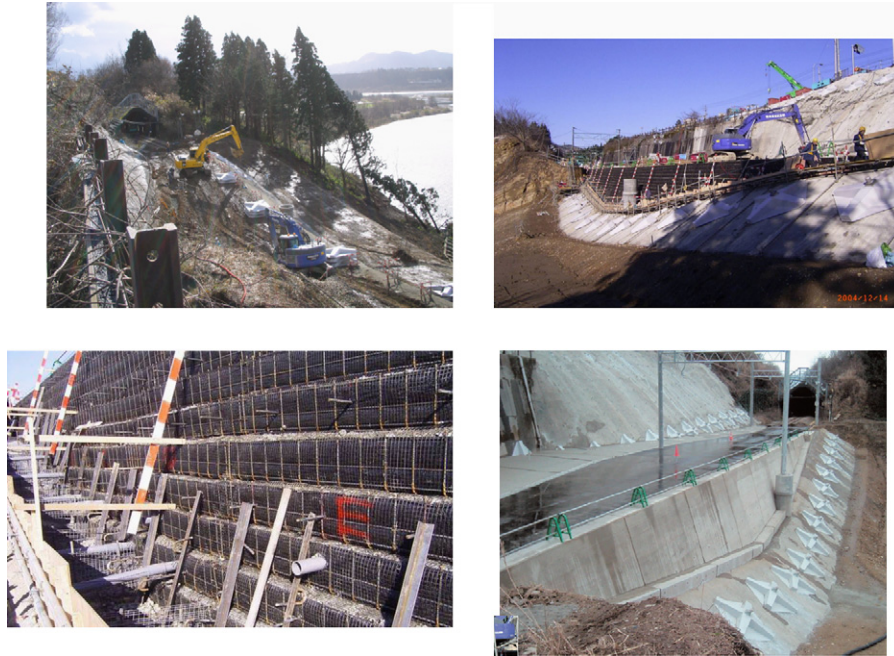
Fig. 22. Reconstruction to a GRS-RW with a full-height rigid facing, site 1 (cf. Fig. 20b).

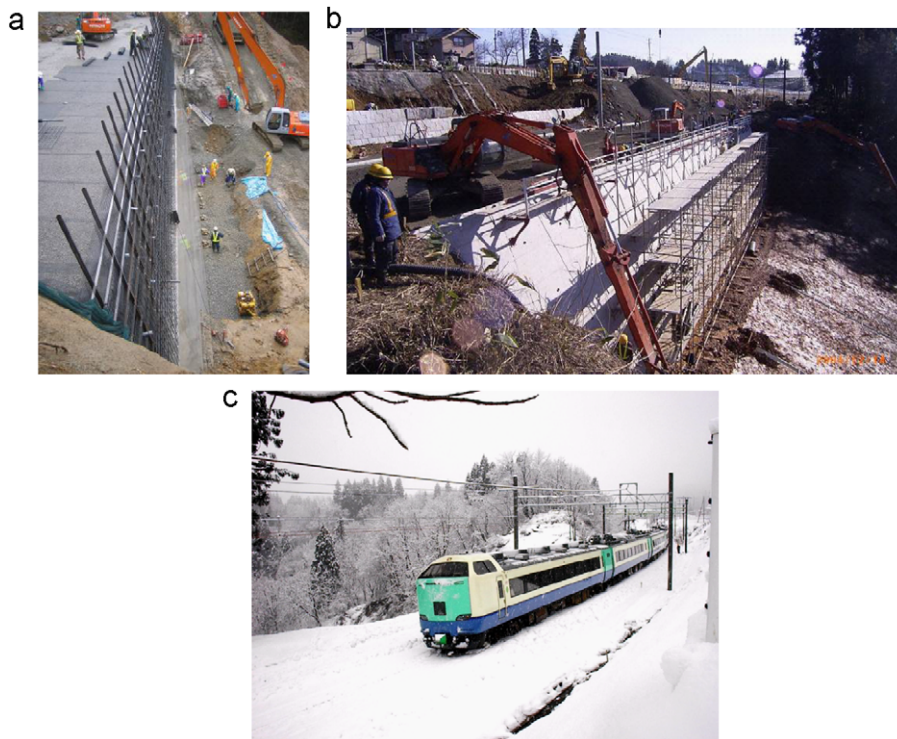
Fig. 23. Reconstruction to a GRS-RW with a full-height rigid facing, site 2 (cf. Fig. 19b).

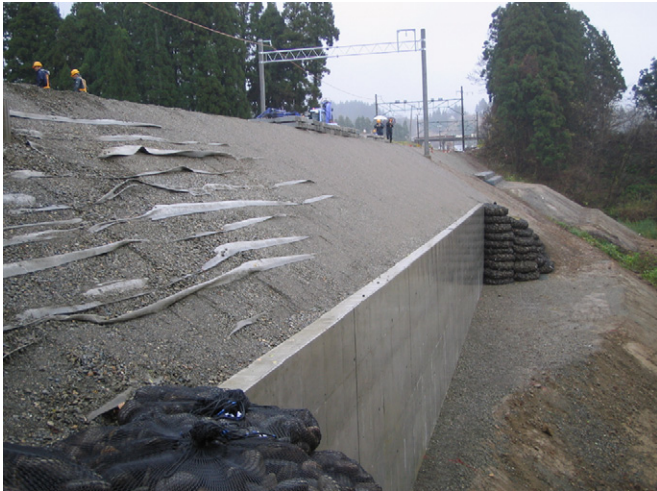
Fig. 24. Reconstruction to a GRS-RW with a full-height rigid facing, site 3 (cf. Fig. 21b).

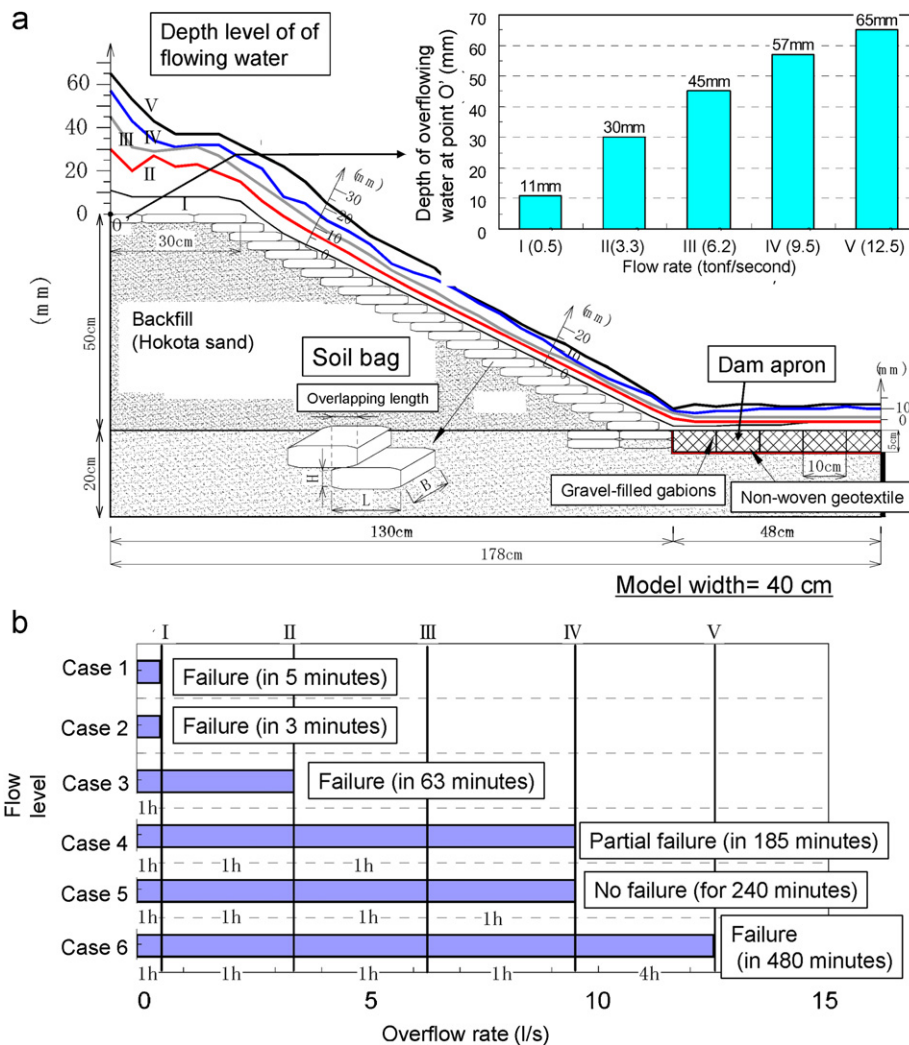
Fig. 27. Model tests to validate the new technology described in Fig. 26 (Matsushima et al., 2005); (a) structure of the model; and (b) summary of the test results.

The protected downstream slope should have a sufficiently high resistance against flood overflow. To validate the above, a series of model tests were performed. Six small models having different arrangements, listed in Table 1, were prepared. The model consisted of a 20 cm thick base ground, on which a 50 cm high model earth-fill dam with a slope of 1:2 (V:H) assuming a scale of 1/10 of an assumed prototype was constructed (Fig. 27a). The fill material was Hokota sand (specific gravity  $G_s = 2.676$ , mean diameter

$D_{50} = 0.184$  cm; coefficient of uniformity  $U_c = 5.82$ ; maximum dry density  $\rho_{dmax} = 1.517$  g/cm<sup>3</sup> and optimum water content  $w_{opt} = 14.3\%$ , compacted at water content  $w = 11.5\%$  to a relative density  $D_r$  equal to 85% (not very dense). The soil bags were made of polyester. With the respective model, the water flow was continued increasing the flow rate every 1 h as shown in Fig. 27b.

The test results (Fig. 27b) showed that the stability against overflow increased by protecting the slope by using soil bags with sufficient overlapping between the vertically adjacent soil bags. That is:

- (1) Case 1: The slope soil was eroded gradually with time by flowing water that passed below the non-woven

geotextile sheets, finally resulting into a sudden shallow failure of the slope.

- (2) *Case 2*: The slope was protected with soil bags with no overlapping between vertically adjacent soil bags. Sliding at the interface between the slope and the soil bags was induced by flow water that reached the interface when the flow rate was still low. The sliding described above resulted in a sudden slide down of all the soil bags.
- (3) *Cases 3, 4 and 5*: By using longer soil bags with larger overlapping between the vertically adjacent bags, the slope became more stable with a less amount of erosion of slope soil.
