Model tests on the stability of GRS integral bridge against tsunami load

ABSTRACT

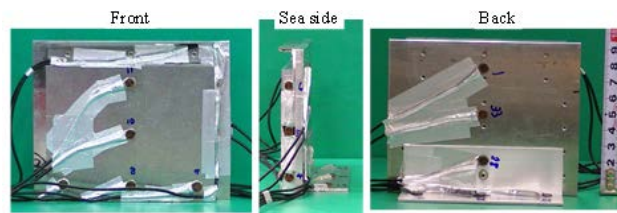
Fig. 8. Pressure sensors placed on the abutment of conventional type bridge model.

Wave pressure and earth pressure were measured by using small disk-type pressure transducers with 0.6 mm

in thickness and 6 mm in diameter. They were glued on the model as shown in Fig. 8.

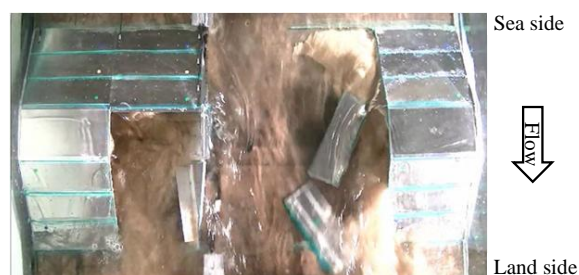
Fig. 9. During overflow in case 01-2.

In case 01 on the conventional type bridge, two waves were applied. The girder was washed away by the first wave. As the damage to the abutment and backfill was not noticeable, the second wave was applied consecutively to the model that had lost the girder. The panel immediately behind the abutment on the crest of the embankment (i.e., the one on the right side in Fig. 9) was washed away only two seconds after the start of overflowing of the wave current. Then, erosion and washing away of the backfill material started, followed by continuous erosion of the backfill. Ultimately, the panels on the slopes and the abutments were washed away. This result indicates that the weak points against tsunami current of the conventional type bridge are the girder bearings, the panels on the slopes and the unreinforced backfill. That is, this unstable behaviour is due to the fact that the members of the bridges (i.e., the girder, the abutments, the panels and the approach fills) are not integrated to each other.

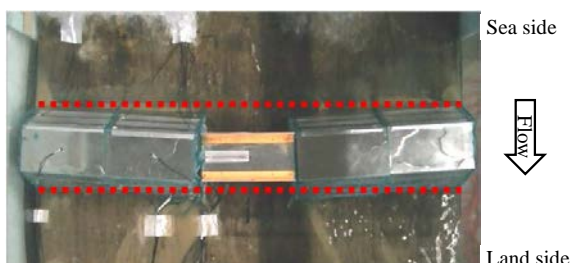
Fig. 10. After fourth wave in case 02-4.

However, three seconds after the start of overflow, the model started deforming to an arch shape by a force of this wave, as shown in Fig. 10. The two broken lines shown in Fig. 10 indicate the initial locations of the toes of the slopes. This deformation of the model continued during subsequent steady state overflow. It was also observed that a small amount of the backfill material was eroded and washed away.

It seems that the internal erosion of backfill took place after the start of the deformation seen in Fig. 10 started. Fig. 11 shows the soil layers overlying the respective geogrid layers observed when dismantling the model from the top after test case 02-4. The eroded area are enclosed in red line. The backfill in the three layers from the top were noticeably eroded, but less in the lower layers. The bottom layer was not eroded. This performance is substantially better than the conventional type bridge model (case 01) and can be attributed to the fact that the panels on the slopes and crest of the embankment survived the waves because of connection of the panels and abutment facings to the geogrid layers reinforcing the backfill. Such an effective suppression of backfill erosion as observed in case 02 eventually increased the stability of the abutment facings and girder of GRS-IB, thus the stability of the whole of the structure.

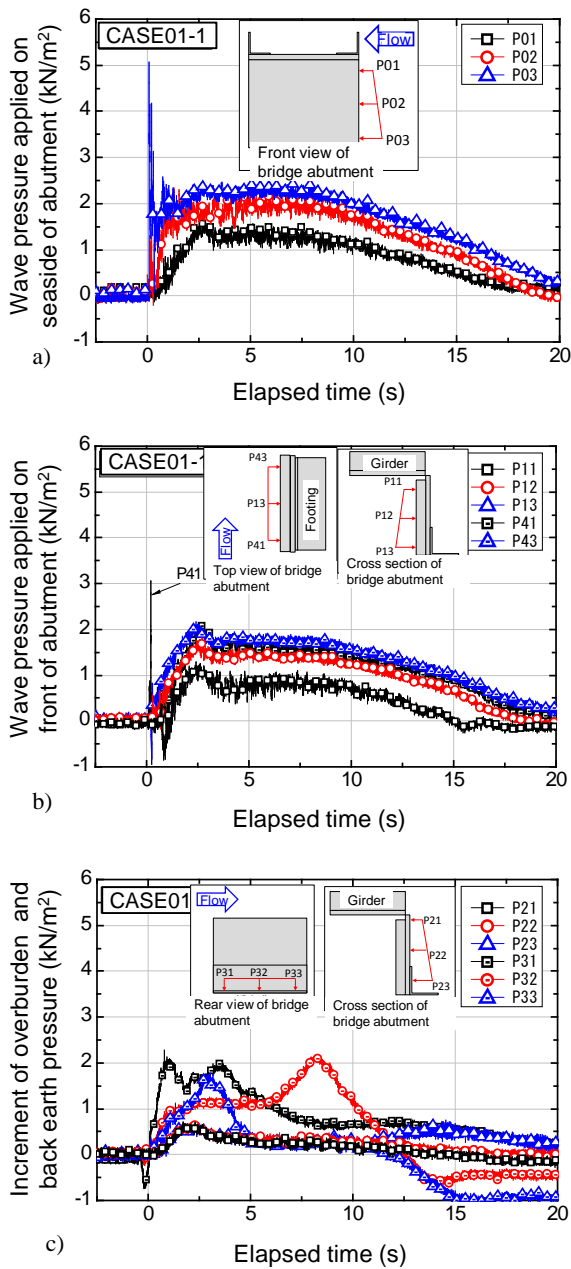
Fig. 12. Test case 01-1 on conventional type bridge model; a) wave pressure applied on seaside of abutment, b) wave pressure applied on the front face of abutment, c) increment of overburden and earth pressure applied on the back face of abutment.

Figs. 12 and 13 show the time histories of water and earth pressures by the first wave measured in test cases 01 and 02. These are typical of all the measurements in this study. In test case 01-1 (Fig. 12), the erosion of backfill was very limited despite the washing away of the girder. The water and earth pressures acting on the abutment presented in Fig. 12 were essentially free from the effects of the girder. In these figures, the horizontal (time) axis was set zero at the time when the wave arrived at the sea side slope of the embankment. Before this moment, the water pressure were essentially zero and set zero at the time of wave arrival. The earth pressures shown in these figures are the increment from the values before the wave arrival. In both tests, the duration of the overflow of wave was around ten seconds. The names shown in these figures, P01 - P54, denote the positions of the sensors.

The following trends of behaviour may be seen from Fig. 12 for the conventional type bridge model. Firstly, the impact water pressure at P03, near the bottom of the upstream slope of the abutment, was about 5 kN/m^2 (Fig. 12a). In comparison, the water pressure at the subsequent steady state during the overflow was much lower and rather constant while similar to the hydrostatic pressure. The water pressure acting on the front face of the abutment in the direction of bridge axis is also similar to the hydrostatic pressure (Fig. 12b). The water pressures at the abutment bottom along the abutment width (P41, P13 & P43) are rather similar. Secondly, the overburden earth pressure on the top face of the heel of the footing of the abutment (P31, P32 & P33) largely fluctuated in the flow direction (Fig. 12c). Yet, these overburden pressures are generally much larger than the lateral earth pressures acting on the back

face of the abutment (P21 & P22). This large increase in the overburden earth pressure on the footing heel was due likely to an increase in the water pressure at the crest of embankment that was transmitted towards the bottom of embankment.
