Large-scale overflow failure tests on embankments using soil bags anchored with geosynthetic reinforcements

ABSTRACT: Every year, a great number of dams for agricultural irrigation are seriously damaged or totally destroyed by flood overflow exceeding the drainage capacity of a spillway. To increase the stability of the downstream slope of such small earth fill dams against overflow, it is proposed to protect the downstream slope by using inclined soil bags anchored with geosynthetic reinforcement. Two tests on hydraulic overflow-induced collapse of the downstream slope were performed on full-scale models, 3.5 m high and 2.3 m wide with a downstream slope of 1V: 1.2H. The first test was conducted on an unreinforced soil slope subjected to a fixed level of overflow and the other was on the geosynthetic soil bags with extended tails (GSET) in which soil bags were placed on the downstream slope and subjected to stepwise increased levels of overflow. Results showed that the GSET model protected by using the soil bag system was stable enough against temporary flooding at overflow levels required in the field. In particular, the rate of progressive erosion of the downstream slope when s

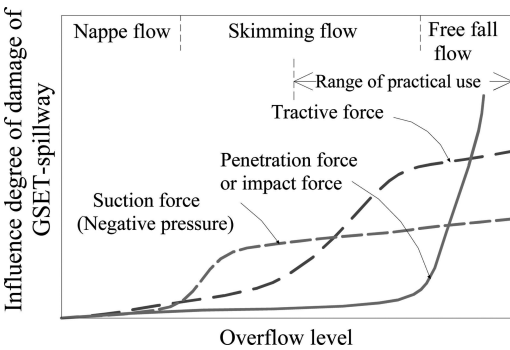
However, no study on the influence of such regimes on the stability of GSET-spillway against overtopping has been performed. Figure 5 shows a conceptual illustration of damage mechanisms, as a function of overflow level, that may affect the stability of the GSET-spillway subjected to overtopping. The main damage mechanisms that are to be taken into account in the design of GSET-spillway against overtopping may include:

- a) suction of backfill material by negative pressure; i.e., washout of soil particles from the slope through spaces between the soil bags;
- b) attrition of geosynthetics by tractive force; and
- c) breakage of geosynthetics by penetration force caused by free water fall.

Figure 5. Damage mechanism of GSET-spillway as a function of overflow level.

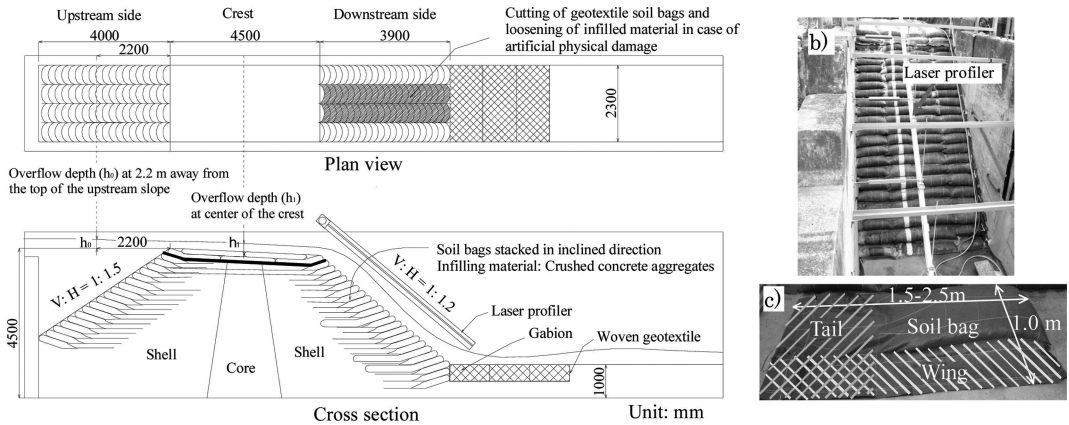
Figure 6a shows a large-scale GSET-spillway model with a total of 24 soil bag steps placed on the downstream slope. The model is 3.5 m high and 2.3 m wide with a downstream slope of 1V: 1.2H. Figure 6b is a view of the completed downstream slope. Figure 6c shows a soil bag, integrated with a tail and a wing while approximately 0.2 m high, 0.6 m wide and 0.6–1.0 m long with a weight of 200 kg. The tail is

Figure 6. Large-scale overflow-induced collapse test: a) Plan view and cross section of full-scale small earth dam; b) Downstream slope of constructed GSET-spillway model; and c) Large-size soil bag integrated with wing and tail.

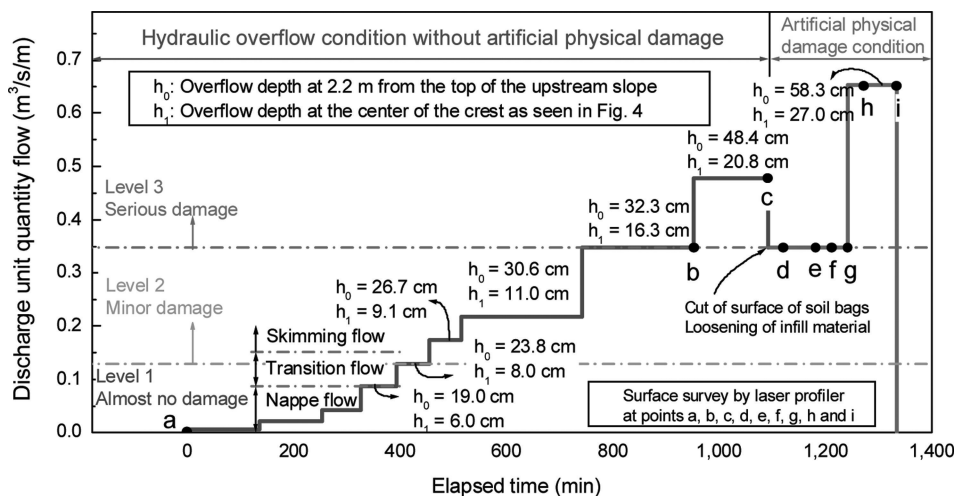
Figure 9 shows the time history of discharge unit quantity flow in the overflow-induced collapse test on the GSET-spillway model. In this figure, the ranges of flow level in which respective damage levels were observed during the test (explained in the next section) are also presented. The test consisted of the following two stages:

As the downstream slope was stable even when the discharge unit quantity flow became as high as $0.48 \text{ m}^3/\text{s}/\text{m}$, it was decided to add the second stage. At the second stage, where the surface deformation by overtopping became noticeable, at every step increase of overflow level at selected stages denoted by a, b, c, d, e, f, g, h and i in Fig. 9, surface surveys of the downstream slope were conducted by laser profiler.

Figure 9. Time history of discharge unit quantity flow for the test performed on GSET-spillway model.

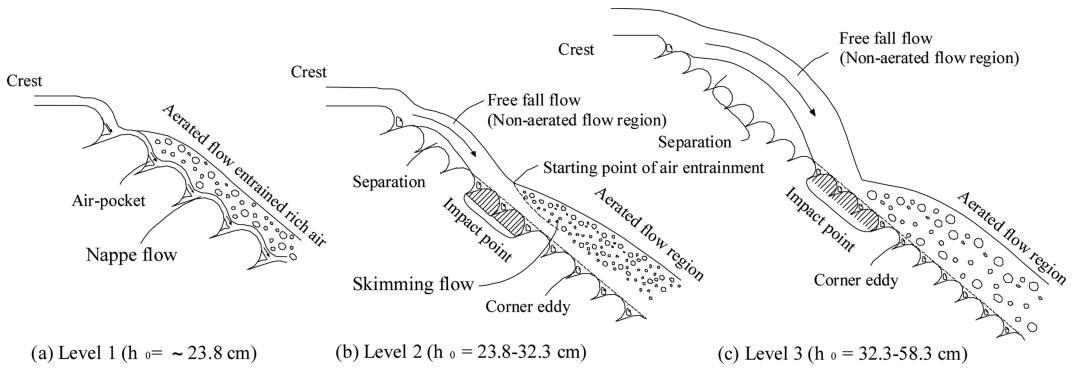
When the overflow depth, h_0 , exceeded 32.3 cm, a very thick vein of head flow with a free fall for a long distance gave severe impact on a limited number of soil bags, resulting in progressive erosion toward the

Figure 10. Schematic flow regimes in overflow levels.

inside of the slope (Photo 5a and Fig. 10c). Fig. 11b presents the profile of the deformed downstream surface at stages b and c in Fig. 9 (before giving artificial physical damage to the soil bags). It was found that a limited number of soil bags deformed severely due to impacts by over-fall of a very thick vein.
