PROCEEDINGS OF THE INTERNATIONAL SYMPOSIUM ON EARTH REINFORCEMENT  
FUKUOKA/KYUSHU/JAPAN/12-14 NOVEMBER 1996

# Performance of reinforced soil structures during the 1995 Hyogo-ken Nanbu Earthquake

**ABSTRACT:** The performance of a number of mechanically stabilized earth retaining walls and nailed slopes during the 1995 Hyogo-ken Nanbu earthquake is reviewed. The behaviour of the reinforced soil retaining walls is compared with that of the conventional retaining walls. Some lessons from the case histories and limitations of the current seismic design methods are discussed. Reconstruction of damaged structures by soil reinforcing techniques is also presented.

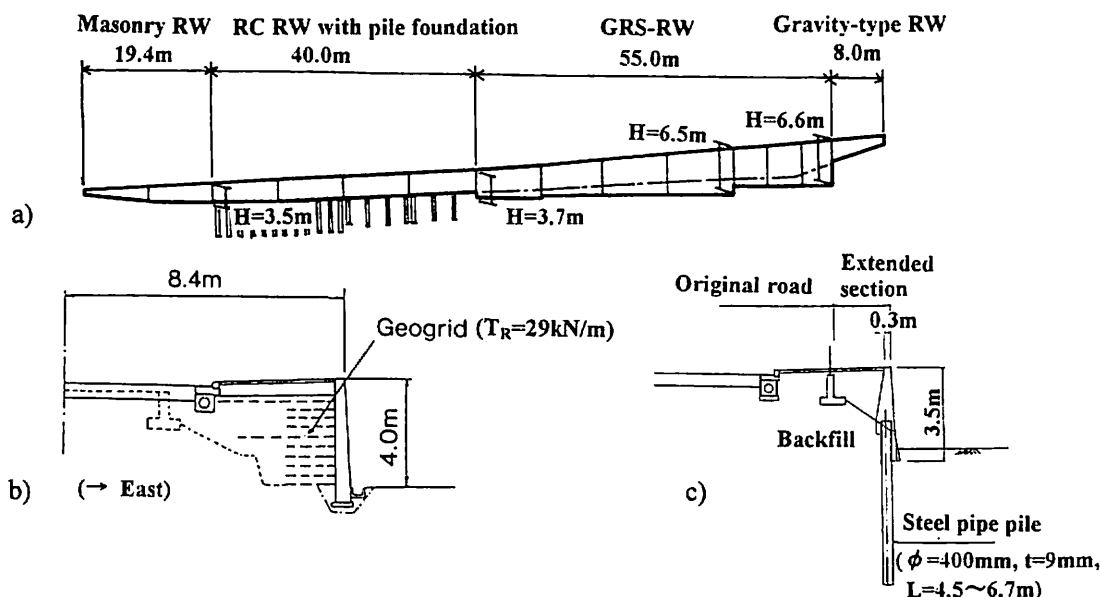
b) Maiko at Tarumi-ku, Kobe City (GR5 in Fig. 3): The wall having Blocks A and B, constructed in 1993 to expand the road immediately east of one of the approach roads to Akashi Kaikyo (Strait) Bridge. The backfill was a well-graded gravel. On the opposite side of the approach road, there exists the GRS-RW without a FHR facing described in section 3.1. Block B (Fig. 20;  $H = 4.9 - 5.1\text{ m}$  and  $L = 60\text{ m}$ ) was located on a steep slope facing the approach road. The facing was supported with well foundations. The wall moved outward about 2 cm at a maximum at the top of the facing. Block A (Fig. 21;  $H = 3.7 - 6.6\text{ m}$  and  $L = 55\text{ m}$ ), facing the

direction opposite to the approach road, moved outward about 1 cm relative to the low-height gravity type RW immediately to the right of the GRS-RW in Fig. 21a. On the left of the GRS-RW in Fig. 21a, a RC wall had been constructed, supported by steel pipe piles (Fig. 21c). Although the height of the RC wall was shorter than that of the GRS-RW, it moved outward about 2 cm relative to the GRS-RW showing a maximum depression of about 10 cm at the road face behind the RC wall. This fact indicates that RC RWs supported by piles could be less cost-effective in terms of seismic stability than GRS-RWs having FHR facings. A similar case was observed on a larger scale at Tanata, to be described later. The displacement of the masonry walls on the left end and the gravity type RW on the right end was not observed, probably due to their small height (about 2.2 m). No further displacement was observed after the earthquake in all these walls.

Fig. 21 a) Front view and b) cross-section of Tarumi GRS-RW (Block A) (GR5 in Fig. 3) and c) cross-section of the adjacent RC RW with piles.

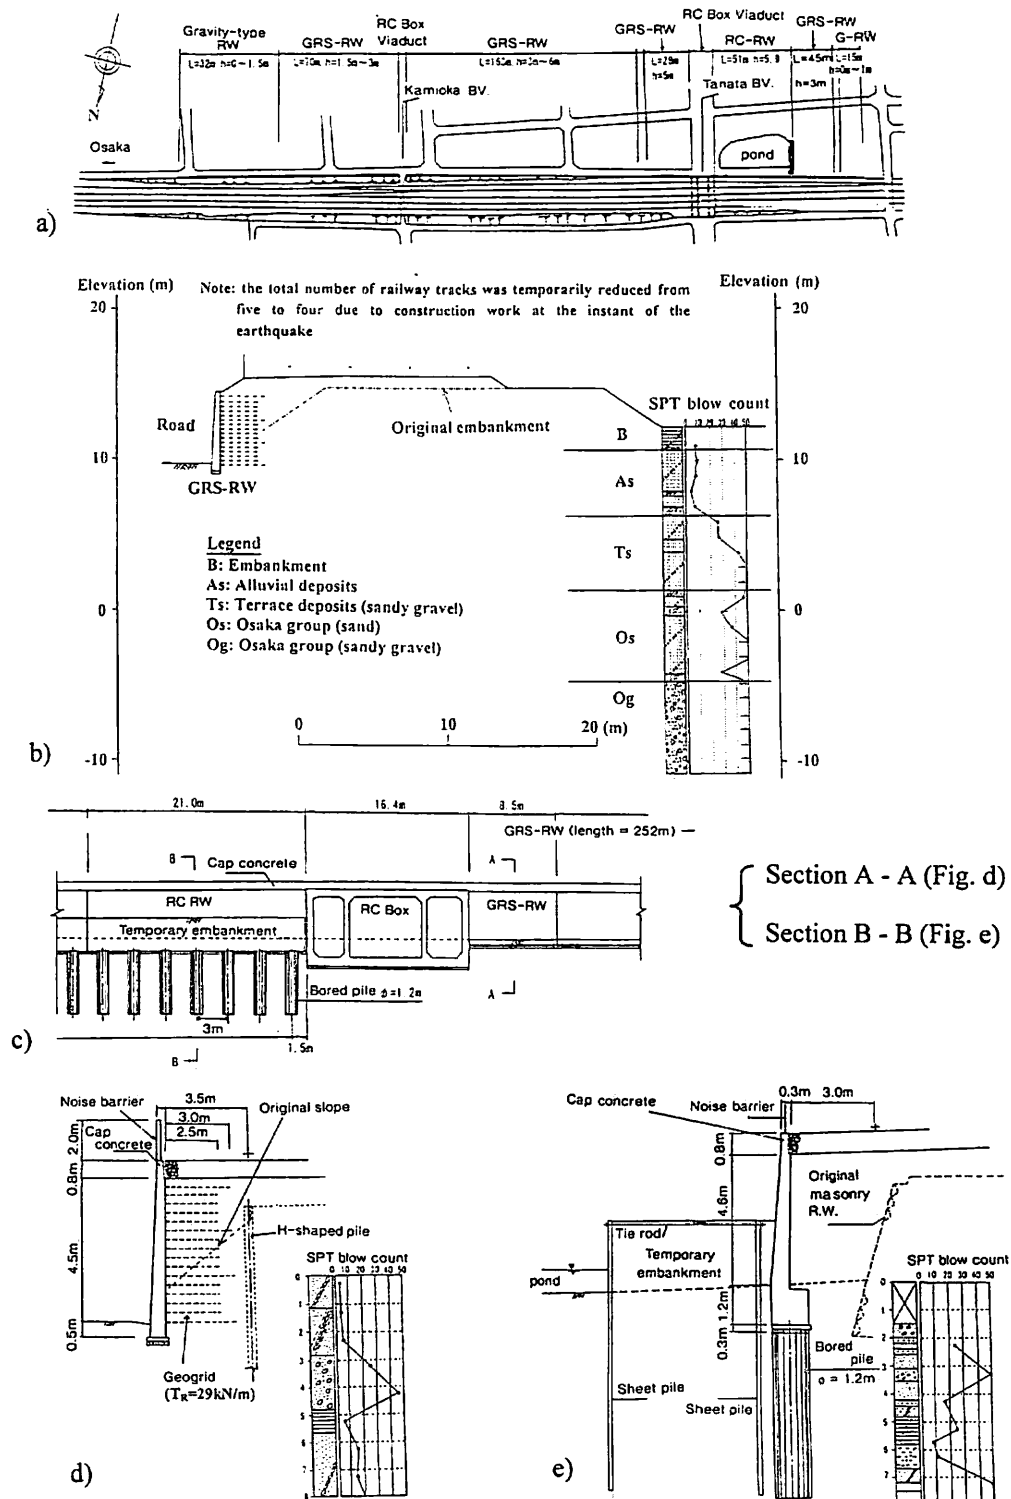
In the areas adjacent to these GRS-RWs having FHR facings, a number of wooden houses, railway and highway embankments and conventional types of RWs were seriously damaged (see Fig. 3). The degree of damage was, however, not as serious as that observed in the areas where the JMA scale was equal to seventh or higher (Fig. 4). In one of these areas, at Mori-Minami-cho 1-chome in Higashi-Nada-ku, Kobe City (the local name is Tanata), GRS-RWs having FHR facings ( $H = 1.5\text{ m} - 6\text{ m}$  and  $L = 305\text{ m}$ ) were completed in February 1992 on the south slope of the embankment of JR Kobe Line (Fig. 23; GR1 in Fig. 4). The wall construction was to increase the number of railway tracks from four to five (Figs. 23a and b). The subsoil condition is relatively good (see Figs. 23d and e). In sections where the wall was higher than 1.5 m, H-shaped steel piles at a spacing of 1.5 m with temporary anchors were provided at two elevations to retain the embankment before the slope was excavated for the construction of the wall (Fig. 23d). The anchors were removed as the GRS-RWs were being constructed.

The bottom of the wall moved outward on average about 5 cm relative to the supporting foundation subsoil, pushing the subsoil in front of the wall laterally. At the highest part of the wall, which was in contact with a RC box culvert structure crossing the railway embankment, the largest outward displacement occurred, which was 26 cm at the top of the wall and 10 cm at the ground surface level (Fig. 24a).

Despite the noticeable movement of the wall, the performance of the GRS-RW walls were considered quite satisfactory for the following reasons;

a) At the site and in the adjacent areas, the seismic intensity was extra-ordinarily high (Fig. 4). More than 80 % of the wooden houses in front of the wall totally collapsed, but most of them were not particularly old (Fig. 25). In the areas surrounding the wall, many RC buildings and RC piers for highways were seriously damaged or totally collapsed. No doubt, this GRS-RW experienced the highest seismic load among the modern GRS-RWs.

b) On the opposite side of the RC box structure, a RC RW with a largest height of about 6 m was constructed concurrently with the GRS-RW (Fig. 23e). The wall was supported by a row of bored piles, despite the sub-surface condition was similar to that of the GRS-RW. Consequently, the con-

struction cost per wall length for the RC RW was about double to triple that for the GRS-RW. The RC RW displaced similarly to the GRS-RW; i.e., at the interface with the side of the RC box structure, the outward lateral displacement was 21.5 cm at the top and 10 cm at the ground surface level (Fig. 24b). This comparable behaviour of these two different types of RWs constructed adjacent to each other was similar to that at Maiko described above. Moreover, the GRS-RW having a FHR facing had been constructed adjacent to and to the west of the RC RW (see Fig. 23a), which was 3 m high and 45 m long. The wall did not move. In the design of RC RWs, such as the one at Tanata, seismic earth pressure calculated by the Mononobe-Okabe method using  $k_h = 0.2$  is resisted by the lateral and rotational resistance of the pile foundation, which results mainly from passive earth pressure in the subsoil in front of the pile foundation. Therefore, some lateral displacement of the pile was inevitable to mobilize the large passive earth pressure.

Fig. 23 a) Plan, b) cross-section of the embankment and c) front view from the south and cross-sections of d) GRS-RW and e) RC RW with pile (GR1 in Fig. 4), at Tanata between Ashiya and Setsu-motoyama Stations, JR Kobe Line.

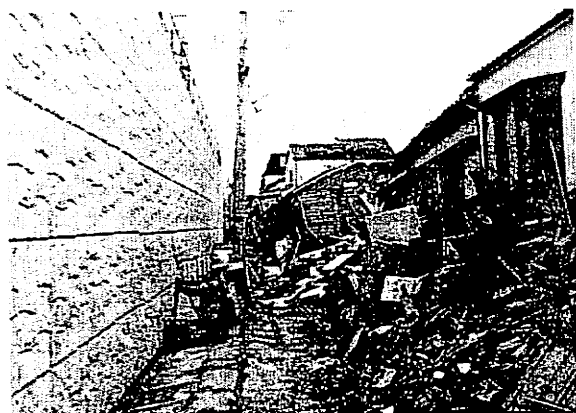
Fig. 25 View in front of the GRS-RW immediately after the earthquake

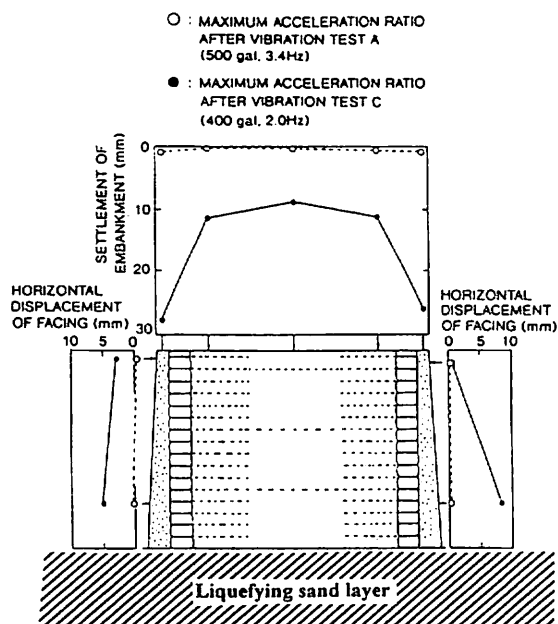
constructed on a saturated sand layer (Fig. 26). The sand zones on both the sides of the wall liquefied by the application of 360 cycles of sinusoidal loads at a frequency of 2 Hz with a peak acceleration of 400 cm/sec<sup>2</sup>. It seems that the sand zone beneath the center of the wall did not liquefy due to the weight of the wall, as seen from the excess pore water pressure recorded beneath the center of the wall. As a result, the facings settled about 2cm relative to the reinfor-

Fig. 26 Deformation of a large GRS-RW model constructed on a liquefied sand deposit (after Fig. 5 of Murata et al., 1994).

-ced backfill, but the wall maintained its integrity. This result suggests that when the foundation subsoil liquefies, a GRS-RW having a FHR facing will deform and displace more than when the subsoil does not liquefy, but may not totally collapse.

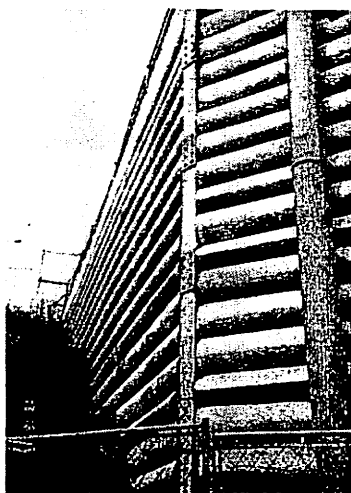
Fig. 31 Temporary Terre Armee wall at Tarumi-ku (by the courtesy of Prof. Akagi, T. of Toyo University).

There was a 6-7 m high temporary Terre Armee wall with a metal skin facing at Tarumi-ku for the construction of an approach road to Akashi Kaikyo Bridge. Some part of the facing, particularly near the bottom, was compressed noticeably (Fig. 31, TA4 in Fig. 3), inducing some outward displacement and settlement at the entire wall. As the wall did not show any sign of total collapse, only some remedy work was performed.

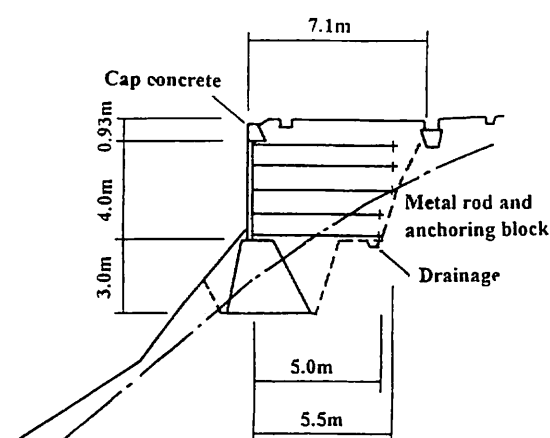
Fig. 32 Cross-section of a multiple-anchor soil RW (MA in Fig. 3).

In the mountain areas, where the seismic intensity was lower than in the areas shown in Fig. 4, some multiple-anchor soil RWs had been constructed. Precast RC panels were anchored with steel tie rods having small anchor concrete blocks at the deepest ends. The wall shown in Fig. 32 (MA in Fig. 3) had a largest wall height of 4.6 m and a total wall area of 87 m<sup>2</sup> (JMAA, 1995). No structural damage and deformation was observed at the wall face, but the cap concrete, that was not anchored, moved backward slightly.

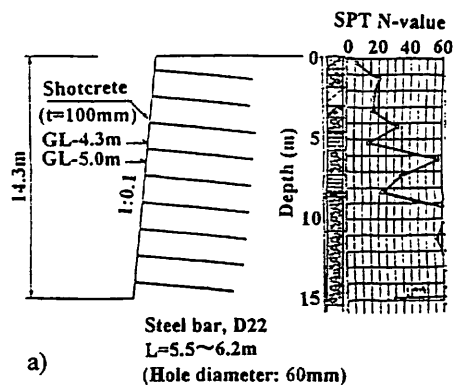
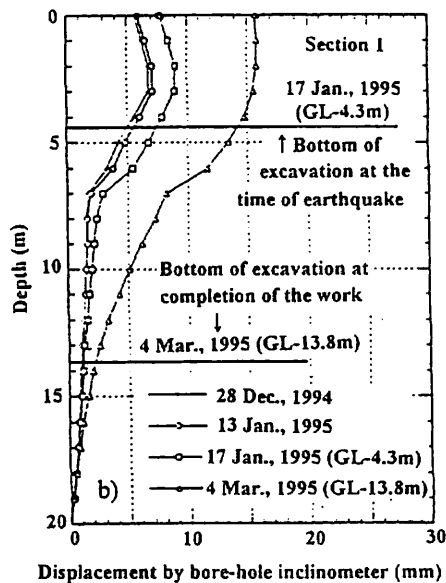
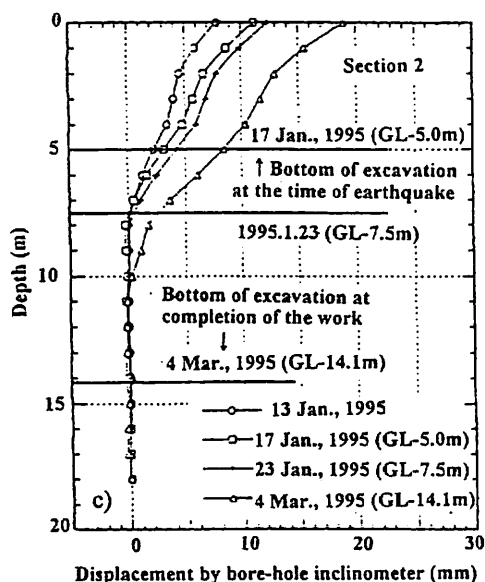
Among them, perhaps the behaviour of the nailed wall NS6 (Fig. 3) was most carefully monitored at the time of the earthquake. The slope was in the process of excavation while having exhibited noticeable deformation (Fig. 34) (Fujii et al., 1996). The wall was nearly vertical while the soil was not very stiff. At the time of the earthquake, the slope had been excavated to a depth about 4.0 - 5.0 m. The wall displaced outward 1.9 mm and 3.2 mm at the largest at the measuring sections Nos. 1 and 2, showing an overturning mode as observed before and after the earthquake. No damage to the houses and other structures in the adjacent areas was observed,

because the site was a bit far away from the epicenter and the estimated PHGA was relatively low. It seems that the slope was already near the critical state at the time of the earthquake, and the slope would have not been stable without nailing during the earthquake. Despite higher PHGAs, the other slopes were more stable probably due to better soil conditions and/or larger inclination of the slopes.

Fig. 34 a) Cross-section at the end of excavation and b) displacements at the slope face of the nailed slope NS6 in Fig. 3 (Fujii et al., 1996).

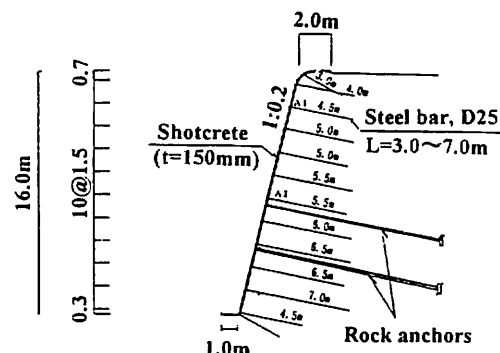
A nailed slope located in Awaji Island (NS7 in Fig.3),

on an approach road to Akashi Kaikyo Bridge, was located closest to the epicenter (Fig. 35). Before the earthquake, some deformation of the excavated slope face had been noticed after having excavated to the bottom of the slope. Therefore, two layers of ground anchor had been installed at depths of 8.7 m and 11.6 m from the slope crest. After well foundations were constructed in front of the slope, the space between the slope face and the back face of the well foundation had been backfilled with

Fig. 35 Cross-section of a nailed slope in Awaji Island (NS7 in Fig. 3; Tsukuda et al., 1996).

concrete up to a depth of 9.6 m from the slope crest by the time of the earthquake. The results of pseudo-static seismic analysis performed after the earthquake for the slope with and without nailing showed that the slope had become more stable by nailing (Tsukuda et al., 1996). Although the reinforced slope was not damaged by the earthquake, a safety factor equal to 0.8 was obtained when applying  $k_h = 0.6$ , which is equal to the estimated PHGA/g, normal to the slope face. They considered that this discrepancy was due to the fact that the direction of the PHGA was largely inclined (more than 60 degrees) from the normal to the slope surface. The authors consider, however, that many other factors should be considered as well.

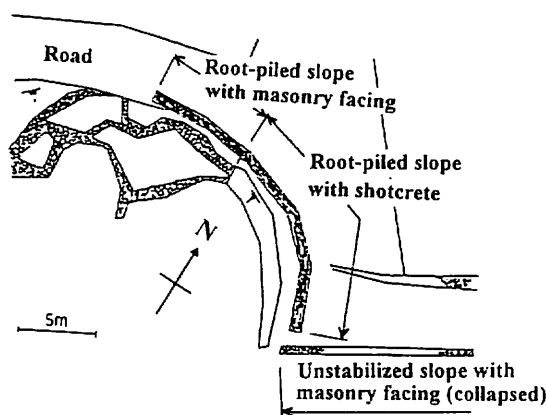
A slope located north-east of Suma-koen Station of the Sanyo Dentetsu railway (RP1; Fig. 36) (see Fig. 3) experienced an estimated PHGA of about 500 gals. A 6 - 7 m high slope had been stabilized by root piling, adjacent to a 1 - 3 m high slope that had been retained only by a masonry RW. The slope was of a residual soil, basically a gravelly sand with inter-bedded clay. The root-piled slope had two different facings, masonry and shotcrete. A number of hair cracks were observed on the shotcrete facing and on the road face behind the wall face, and an opening of 5 cm appeared between the masonry and shotcrete facings. However, the damage was not serious at all. The deformation of the masonry facing was smaller. Compared with the above, the masonry facing of the unstabilized slope collapsed, and several nearby wooden houses were seriously damaged.

Fig. 36 Plan of the root-piled slopes and adjacent damaged unreinforced slope near Suma-Koen (RP1 in Fig. 3; after Fujii et al., 1996).

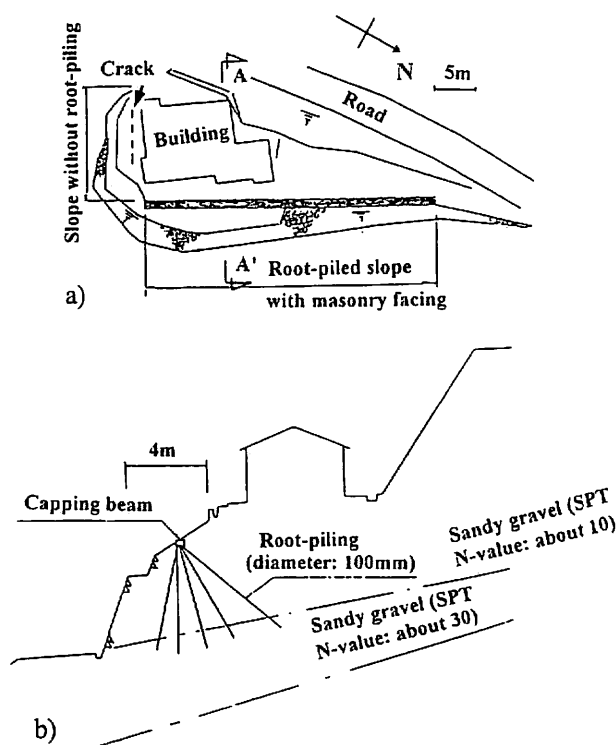
In the second case located south of JR Takarazuka Station on the right bank of Mukogawa river (RP2 in Fig. 3; Fig. 37), the estimated PHGA was about 500

Fig. 37 a) Plan of the root-piled slope and adjacent damaged unreinforced slopes and b) cross-section A-A' of the root-piled slope near Takarazuka (RP2 in Fig. 3; after Fujii et al., 1996).

gals. An about 7 m high slope having a masonry RW had been stabilized by root piling, while the adjacent slope with a height of 5.0 m at the maximum had been retained only by a masonry RW. The slope soil was basically a sandy gravel. In the root-piled slope, the soil mass between the wall face and the root piles seems to have moved slightly outward

while the root-piled zone and the soil behind it did not, judging from some small cracks and no cracks on the ground surfaces, respectively, in front of and behind the capping beam. Compared with the good performance of the root-piled slope, on the crest of the slope without root-piling, a crack with a maximum width of about 20 cm appeared immediately behind the masonry RW, associated with a 7 cm deep depression at a distance of 20 cm from the masonry RW. This fact shows that the unstabilized slope moved outward to a some extent.

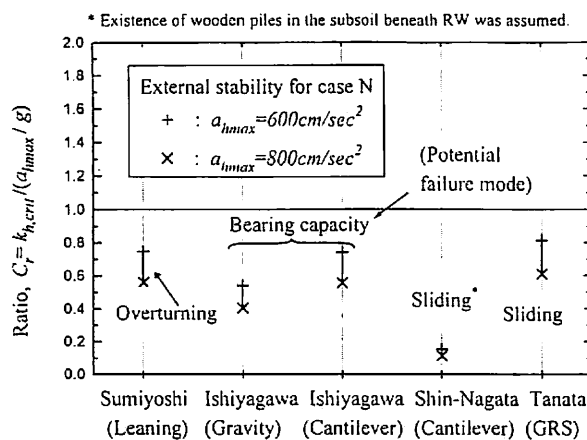
where  $k_{h, \text{crit}}$  is the critical horizontal seismic coefficient yielding a safety factor of unity. The value of PHGA was estimated as approximately 600 gal to 800 gal based on Fig. 5. For the RWs which actually failed, the values of  $k_h = C_r \cdot (\text{PHGA}/g)$  as obtained would have under-estimated the correct values to be used in the aseismic design, because the critical PHGA at which the structures were about to fail should be equal to or smaller than the actual PHGA. The reverse is true for the RWs which did not fail.

In Fig. 40, the potential failure modes against external instability are also indicated. These failure modes were found consistent with the observed behaviour. The value of  $C_r$  against external instability for the GRS-RW at Tanata was 0.6 - 0.8, which was similar to those for the other conventional RWs excluding the cantilever-type RC RW at Shin-Nagata (CL2 in Fig. 4; see also Fig. 11). A very low value of  $C_r$  for the wall at Shin-Nagata would be due to the fact that the backfill was considerably sloped. Based on the results shown in Fig. 40 (excluding the wall at Shin-Nagata), the following conclusions could be drawn:

Fig. 40 Ratio of critical horizontal seismic coefficient to estimated PHGA for external stability of RWs (after Koseki et al., 1996).
